Annual Inspection

Fritelstockstone Playing Fields

Fritelstock Parish Playing Fields

Inspection Ref: 53482

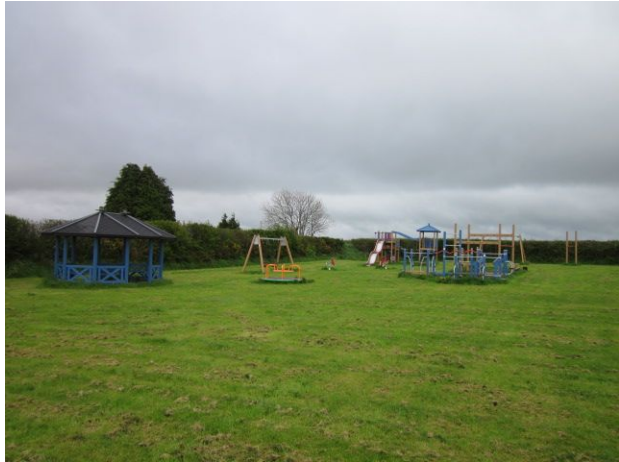
Item: Ancillary Items - Site General
Manufacturer: Unknown
Surface Type: N/A
Equipment Compliance: N/A
Surface Area Compliance: N/A

The grass is very long around the equipment - Cut and maintain the grass

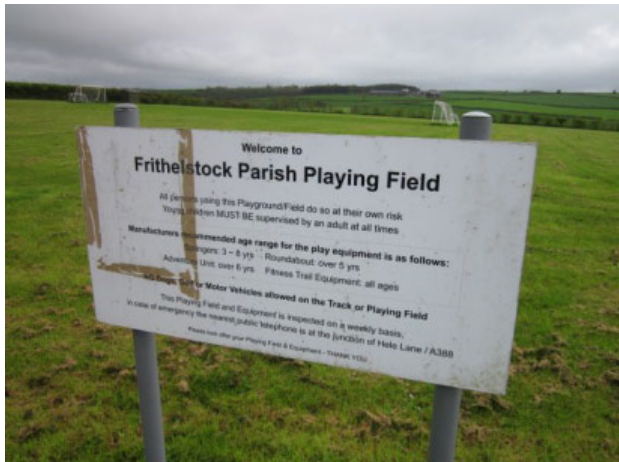
Item: Ancillary Items - Sign
Manufacturer: Owner/Operator
Surface Type: N/A
Equipment Compliance: N/A
Surface Area Compliance: N/A

This item is satisfactory - no work required

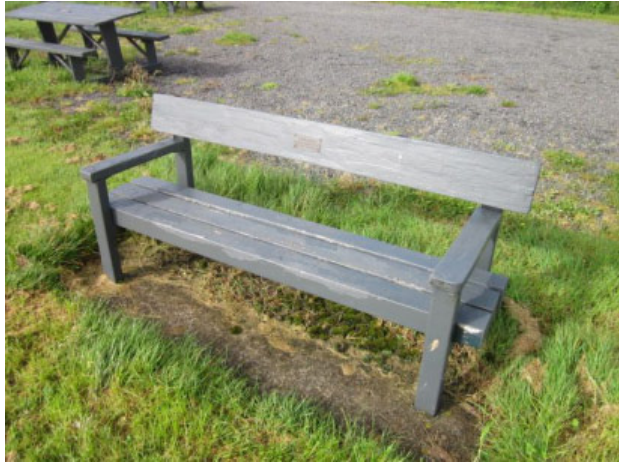
Item: Ancillary Items - Bench - Timber
Manufacturer: Unknown
Surface Type: N/A
Equipment Compliance: N/A
Surface Area Compliance: N/A

This item is satisfactory - no work required

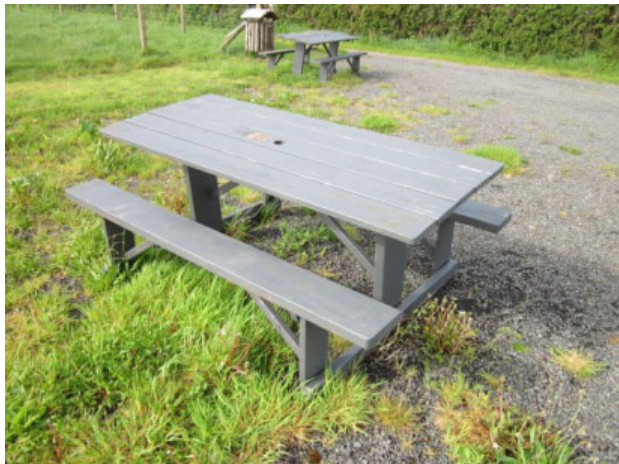
Item: Ancillary Items - Picnic Bench - Wooden
Manufacturer: Unknown
Surface Type: N/A
Equipment Compliance: N/A
Surface Area Compliance: N/A

There is significant rot occurring in the benches resulting in loose frame fixings and the benches being unstable - Repair benches

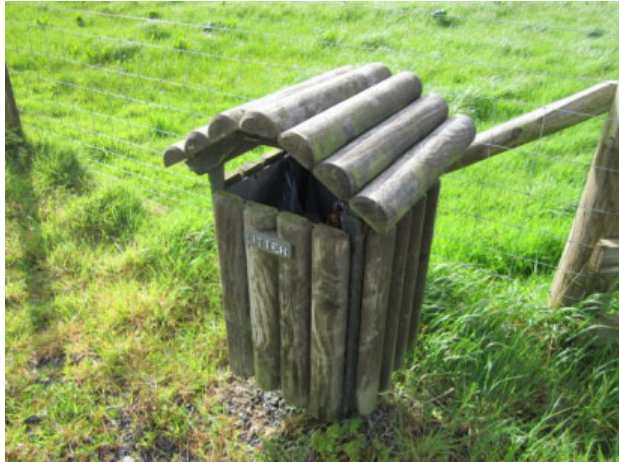
Item: Ancillary Items - Bin - Ground Based
Manufacturer: Unknown
Surface Type: N/A
Equipment Compliance: N/A
Surface Area Compliance: N/A

This item is satisfactory - no work required

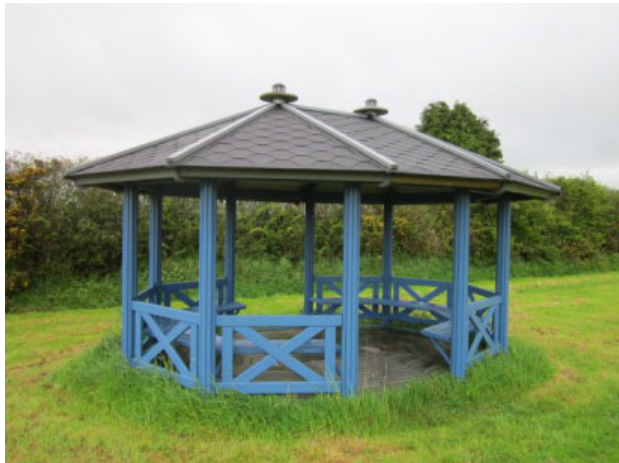
Item: Ancillary Items - Teenage Shelter
Manufacturer: Lappset UK Ltd
Surface Type: Grass
Equipment Compliance: N/A
Surface Area Compliance: N/A

The timber floor of the shelter is slippery - Clean and maintain the floor

There are some protruding bolts under the seats - Cut off protruding bolts

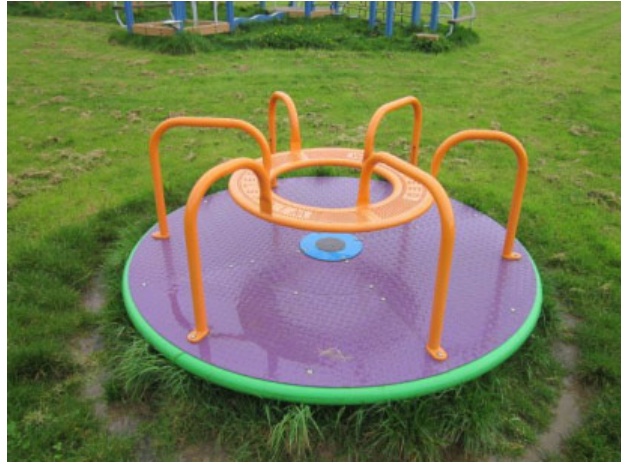
Item: Rotor Play - Roundabout
Manufacturer: Wicksteed
Surface Type: Matta
Equipment Compliance: No
Surface Area Compliance: Yes

The distance between the underside of the roundabout platform and the playing surface is in excess of 110mm and contravenes the requirements of BS EN 1176 Part 5 which requires that the distance be maintained between 60mm-110mm - for the entire circumference of the roundabout - Monitor use

There is some movement in the bearings of the roundabout - Monitor condition and secure/repair as required

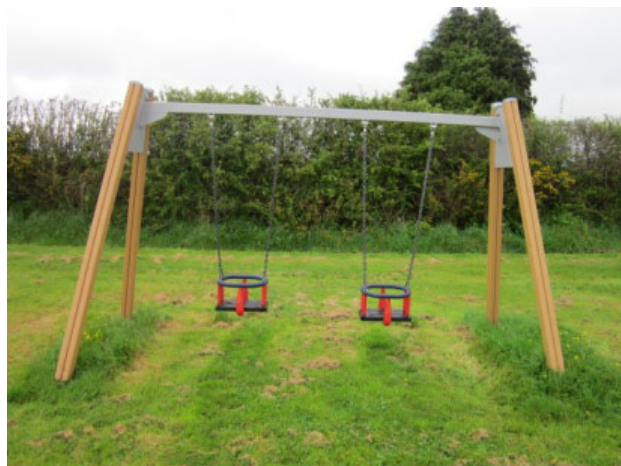
Item: Swings - 1 Bay 2 Seat (cradle)
Manufacturer: Lappset UK Ltd
Surface Type: Grass
Equipment Compliance: No
Surface Area Compliance: Yes

The chain openings are in excess of the 8.6mm recommended by BS EN 1176 - Monitor use and replace with compliant chains during next maintenance cycle.

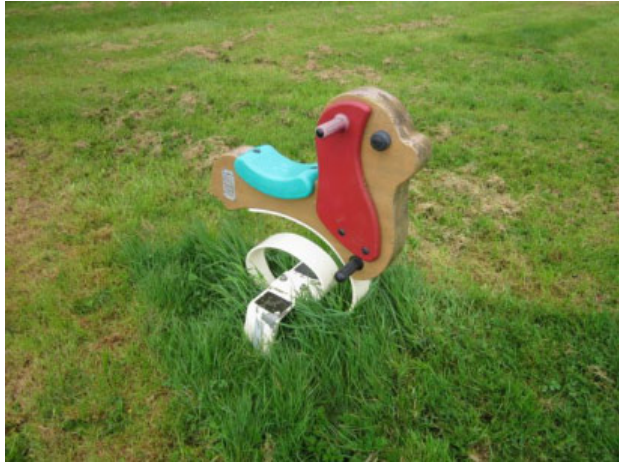
Item: Spring - Misc Springer
Manufacturer: Lappset UK Ltd
Surface Type: Grass
Equipment Compliance: No
Surface Area Compliance: Yes

The end of handgrips and footrests have a cross section of less than 15cm² and fail to meet the requirements of BS EN 1176:2008 Part 6 - Monitor use

There is some movement in the ground of the coil base - Monitor condition

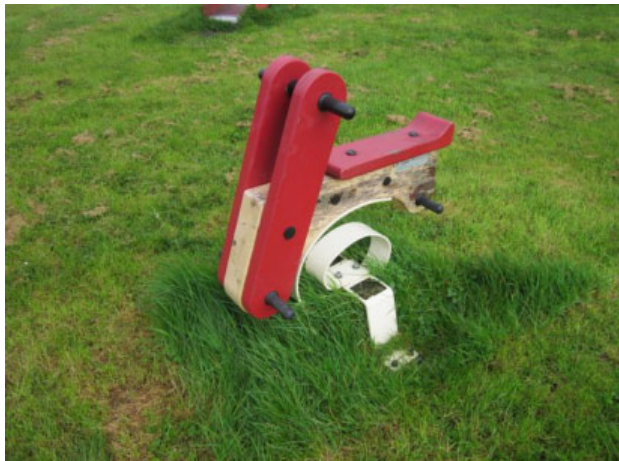
Item: Spring - Spring Bike
Manufacturer: Lappset UK Ltd
Surface Type: Grass
Equipment Compliance: No
Surface Area Compliance: Yes

The end of the handgrips and footrests have a cross section of less than 15cm² and fail to meet the requirements of BS EN 1176:2008 Part 6 - Monitor use

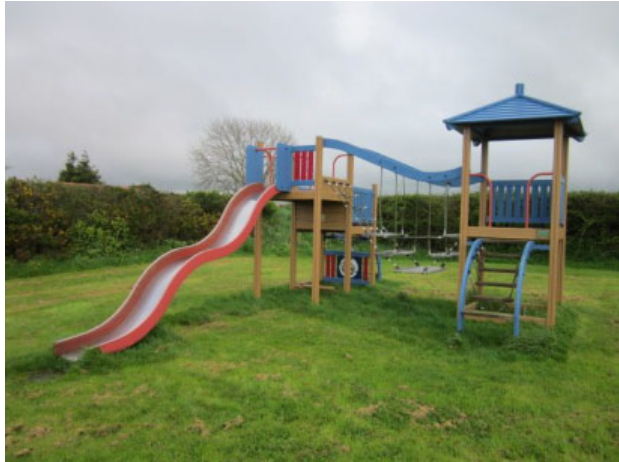
Item: Agility - Multi Play
Manufacturer: Lappset UK Ltd
Surface Type: Grass
Equipment Compliance: No
Surface Area Compliance: No

The fall height of the item exceeds 1.5m, grass is not deemed a suitable impact absorbing surface for fall heights in excess of 1.5m - Consider providing a suitable impact absorbing surface

The item fails to meet the requirements for head and neck entrapment at the top of the net climber and above the top swinging step BS EN 1176 Part 1 - Monitor use

There is a finger entrapment between the platform and the step above the swinging steps - Remove entrapment

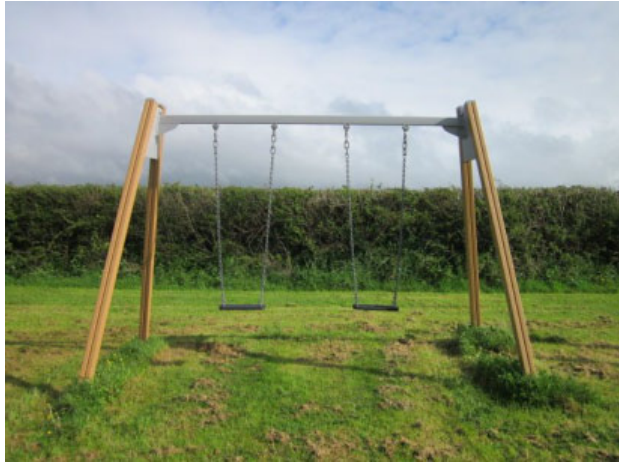
Item: Swings - 1 Bay 2 Seat (flat)
Manufacturer: Lappset UK Ltd
Surface Type: Grass
Equipment Compliance: No
Surface Area Compliance: Yes

The seat heights are in excess of the recommended 635mm seat height - Consider lowering the seats

The chain openings are in excess of the 8.6mm recommended by BS EN 1176 - Monitor use and replace with compliant chains during next maintenance cycle.

There is a pivot block fixing bolt that is not fully inserted into the nylok nut - Adjust

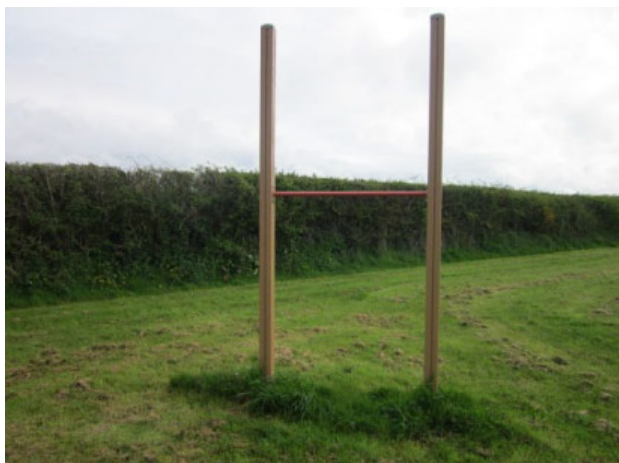
Item: Agility - Somersault Bars
Manufacturer: Lappset UK Ltd
Surface Type: Grass
Equipment Compliance: Yes
Surface Area Compliance: Yes

This item is satisfactory - no work required

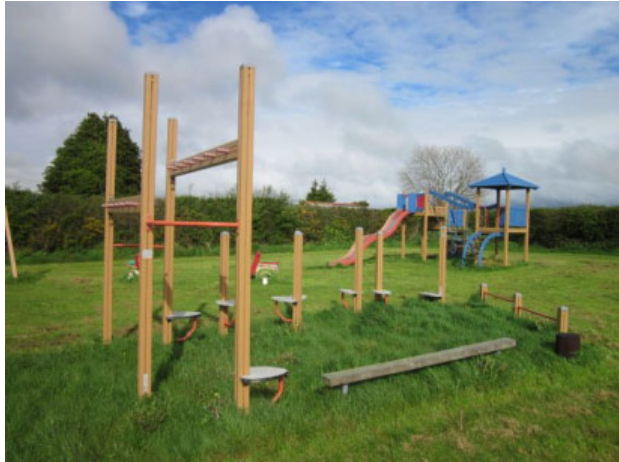
Item: Other - Adventure Trail
Manufacturer: Lappset UK Ltd
Surface Type: Grass
Equipment Compliance: No
Surface Area Compliance: Yes

There is some damage to one of the platforms - Replace the damaged platform

There are platforms in the falling space of the overhead grips - Monitor use

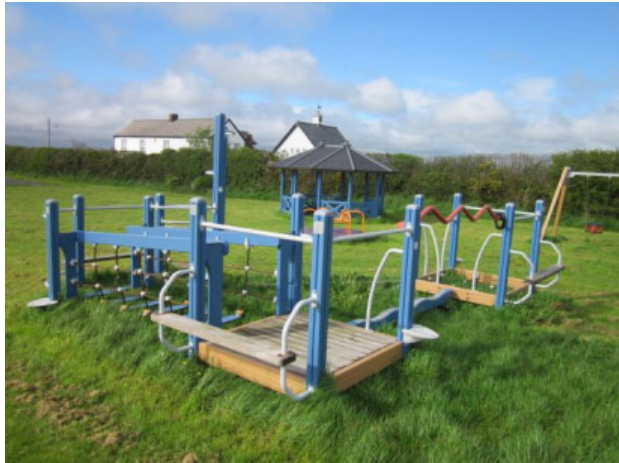
Item: Other - Fitness Trail
Manufacturer: Lappset UK Ltd
Surface Type: Grass
Equipment Compliance: No
Surface Area Compliance: Yes

There are some loose fixings between items in the trail and the posts - Secure loose fixings

There are finger entrapments in the zig zag beam ends - Remove entrapments

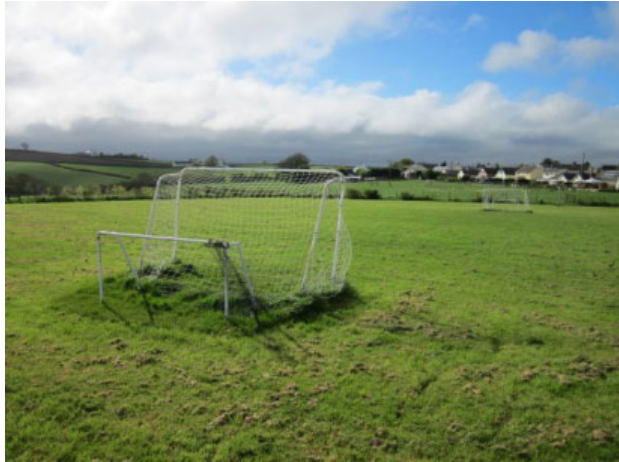
Item: Other - Football Goal
Manufacturer: Unknown
Surface Type: Grass
Equipment Compliance: N/A
Surface Area Compliance: N/A

The nets on the goals are loose and damaged - Repair and secure

The goals are not secured in the ground, they are leaning and can be tipped over - Secure the goals in position

There are some loose fixings to the goal frames - Secure loose fixings

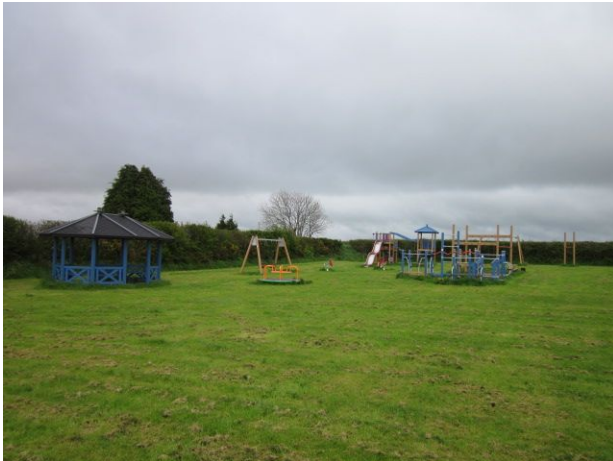
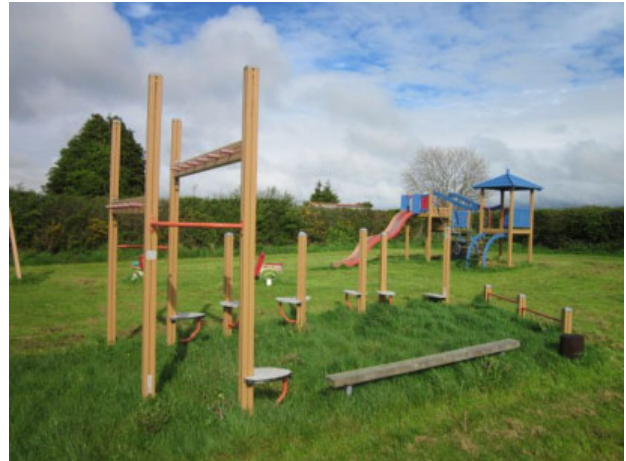
Item: Ancillary Items - Site General
Manufacturer: Unknown

Finding: The grass is very long around the equipment **Action:** Cut and maintain the grass

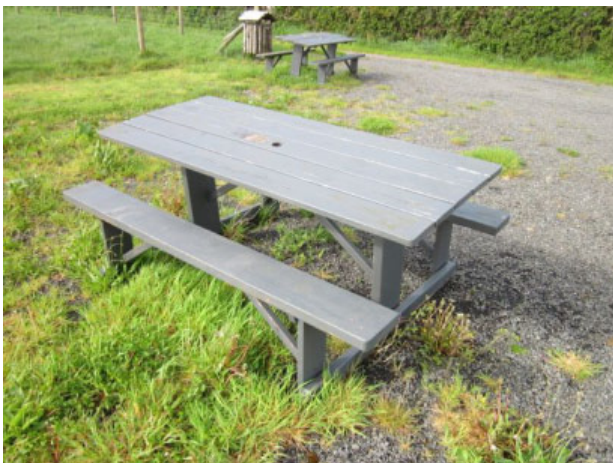
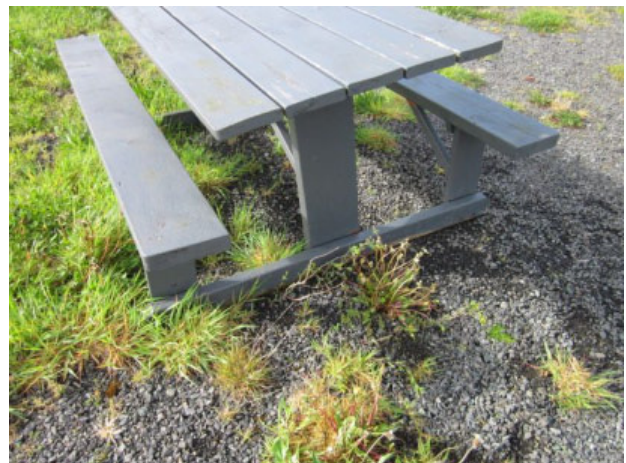
Item: Ancillary Items - Picnic Bench - Wooden
Manufacturer: Unknown

Finding: There is significant rot occurring in the benches resulting in loose frame fixings and the benches being unstable **Action:** Repair benches

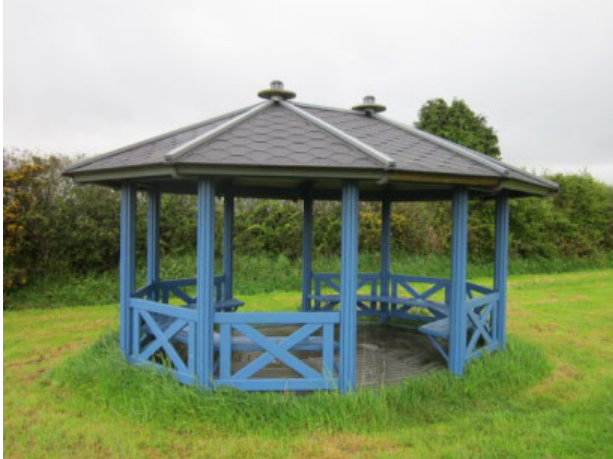
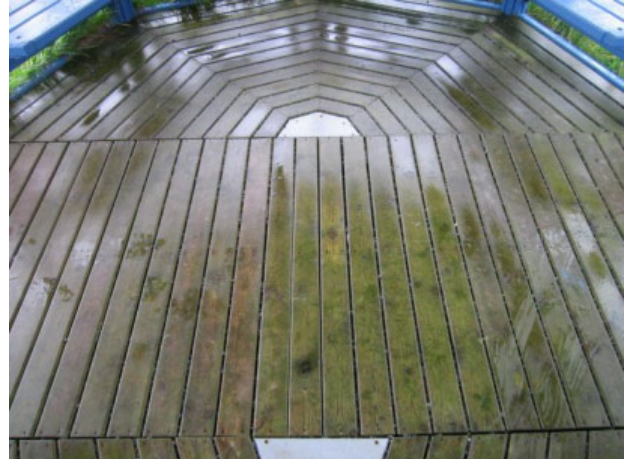
Item: Ancillary Items - Teenage Shelter
Manufacturer: Lappset UK Ltd

Finding: The timber floor of the shelter is slippery

Action: Clean and maintain the floor

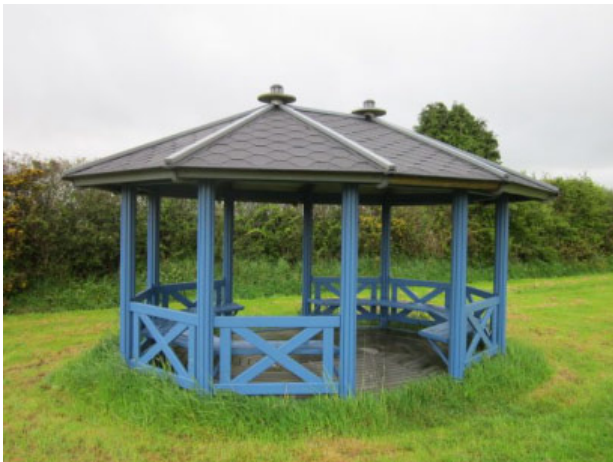
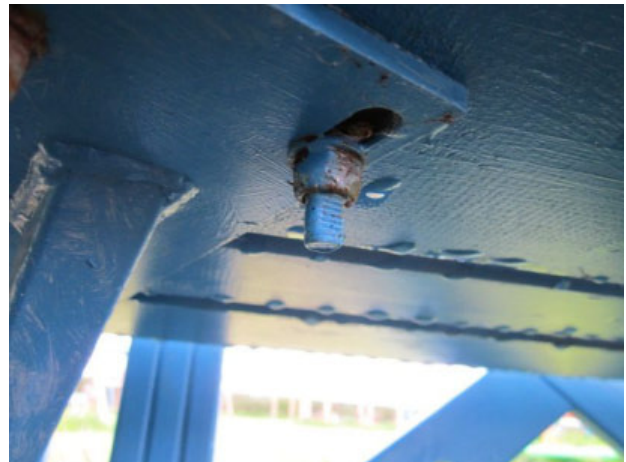
Item: Ancillary Items - Teenage Shelter
Manufacturer: Lappset UK Ltd

Finding: There are some protruding bolts under the seats

Action: Cut off protruding bolts

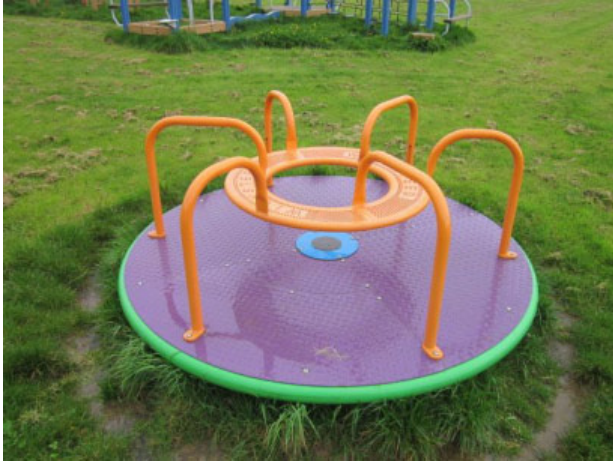
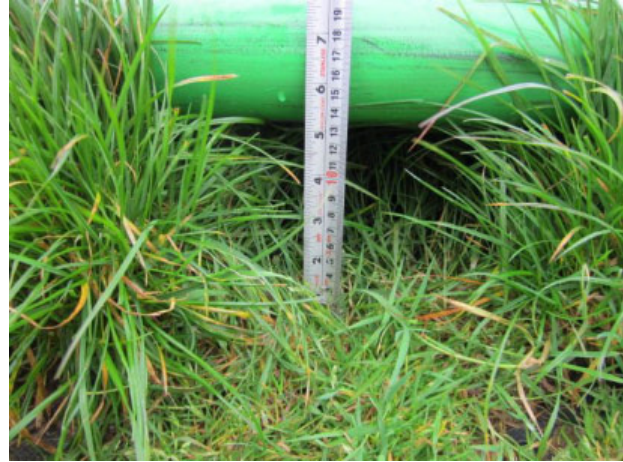
Item: Rotor Play - Roundabout
Manufacturer: Wicksteed

Finding: The distance between the underside of the roundabout platform and the playing surface is in excess of 110mm and contravenes the requirements of BS EN 1176 Part 5 which requires that the distance be maintained between 60mm-110mm - for the entire circumference of the roundabout

Action: Monitor use

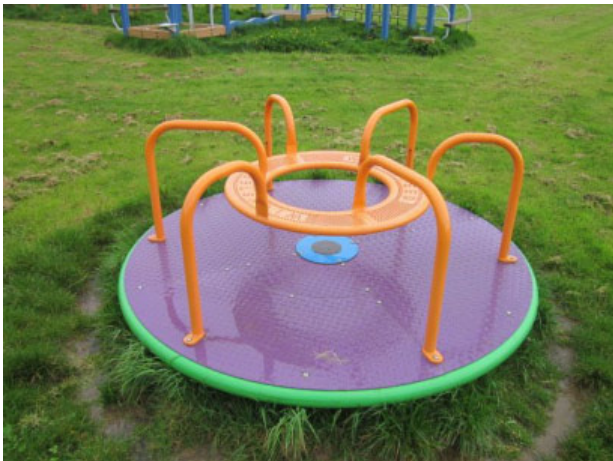
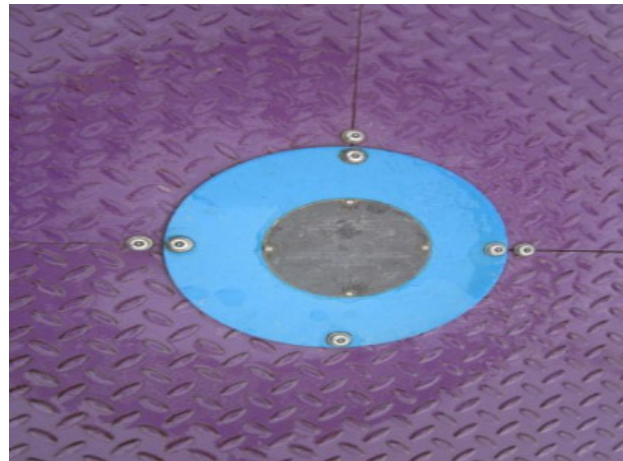
Item: Rotor Play - Roundabout
Manufacturer: Wicksteed

Finding: There is some movement in the bearings of the roundabout

Action: Monitor condition and secure/repair as required

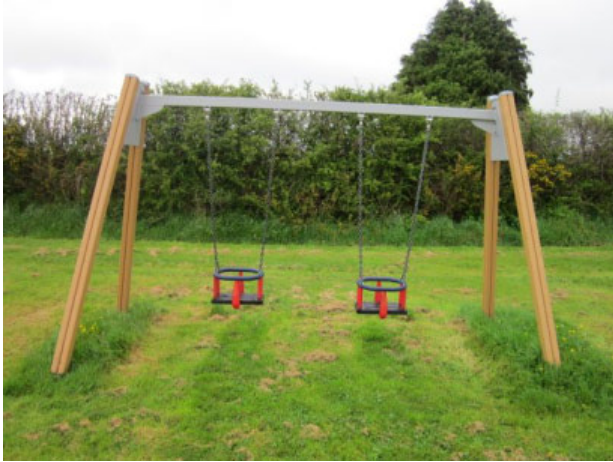
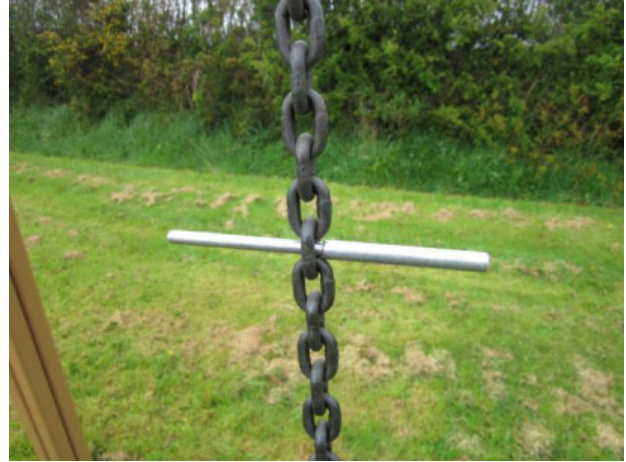
Item: Swings - 1 Bay 2 Seat (cradle)
Manufacturer: Lappset UK Ltd

Finding: The chain openings are in excess of the 8.6mm recommended by BS EN 1176

Action: Monitor use and replace with compliant chains during next maintenance cycle.

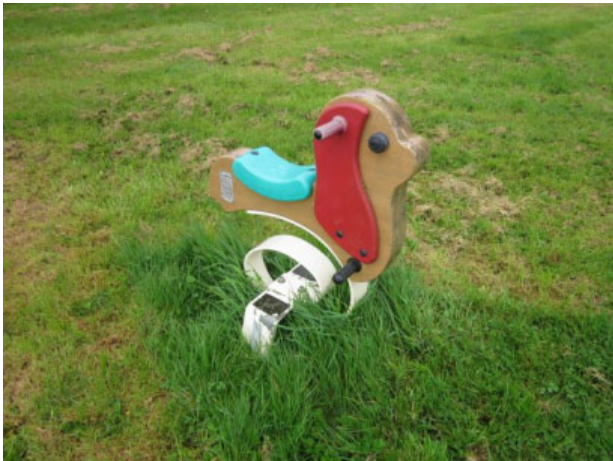
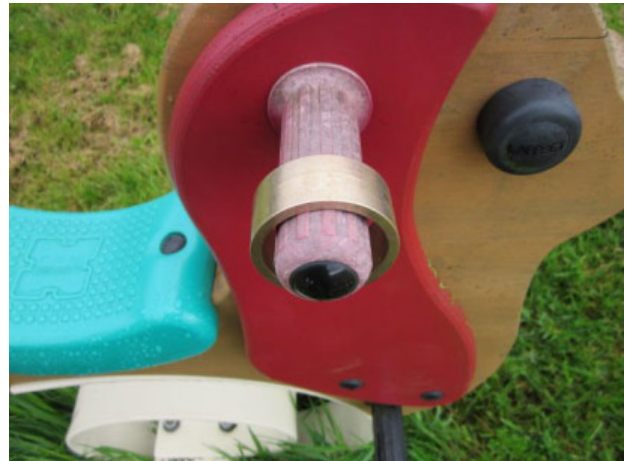
Item: Spring - Misc Springer
Manufacturer: Lappset UK Ltd

Finding: The end of handgrips and footrests have a cross section of less than 15cm² and fail to meet the requirements of BS EN 1176:2008 Part 6

Action: Monitor use

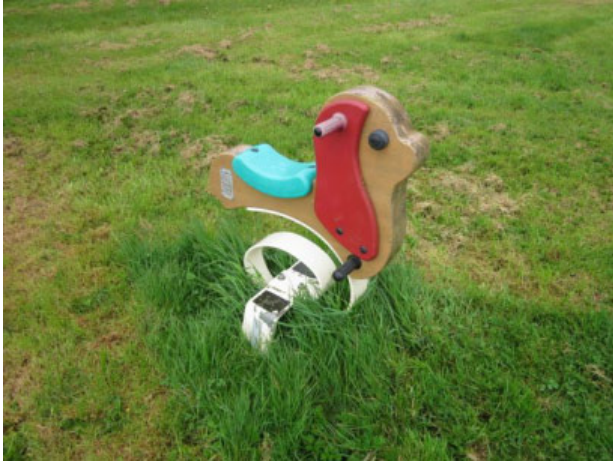
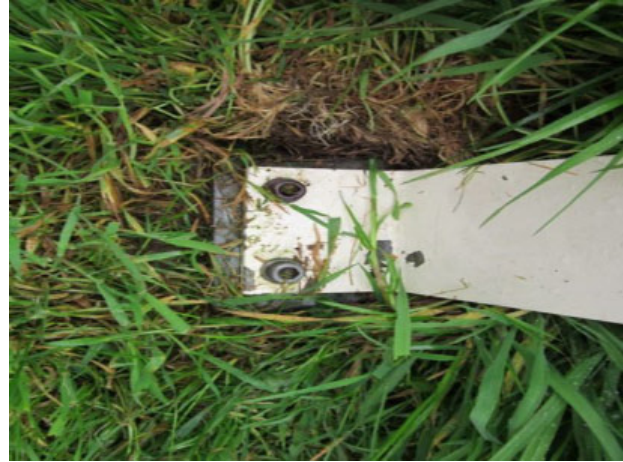
Item: Spring - Misc Springer
Manufacturer: Lappset UK Ltd

Finding: There is some movement in the ground of the coil base
Action: Monitor condition

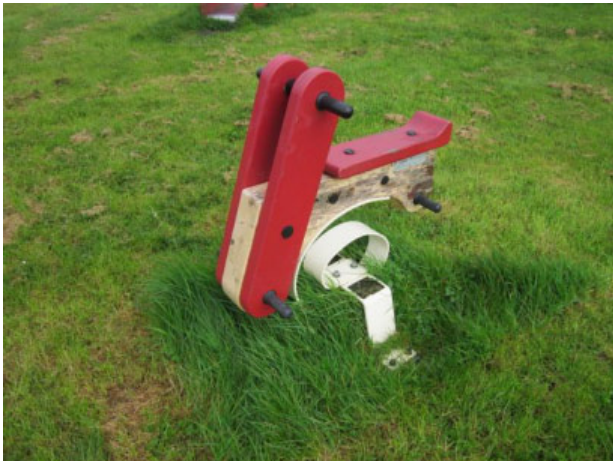
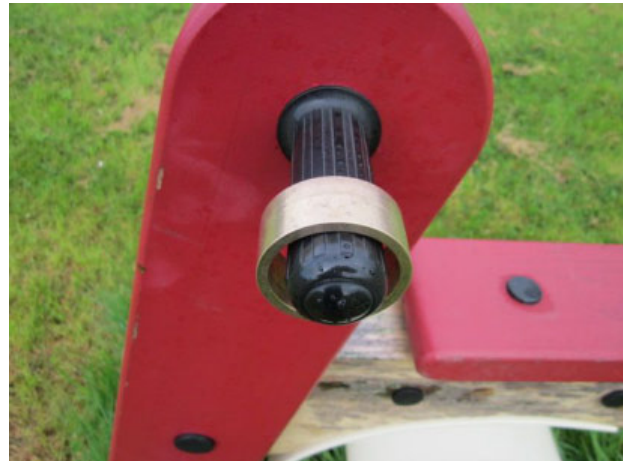
Item: Spring - Spring Bike
Manufacturer: Lappset UK Ltd

Finding: The end of the handgrips and footrests have a cross section of less than 15cm² and fail to meet the requirements of BS EN 1176:2008 Part 6
Action: Monitor use

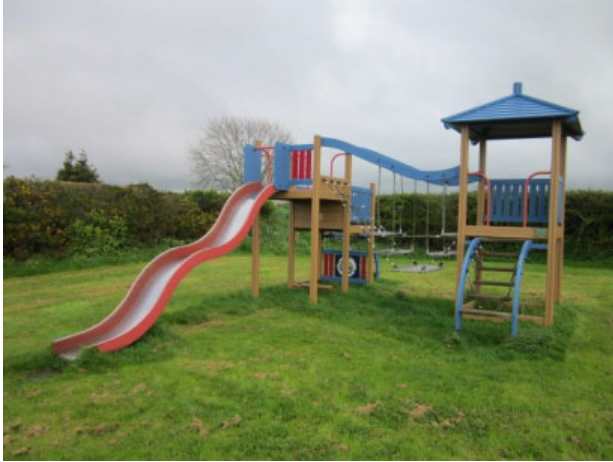
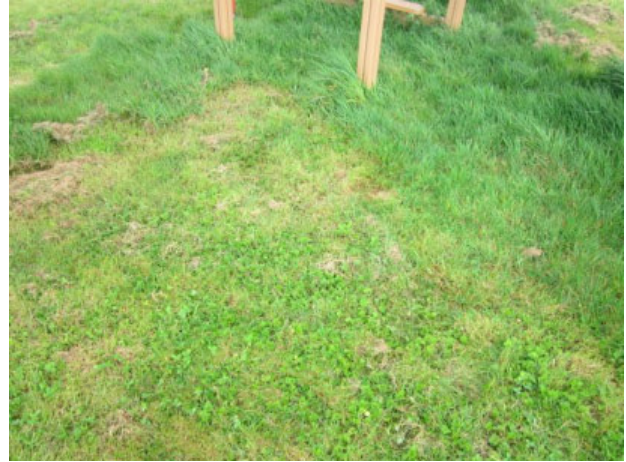
Item: Agility - Multi Play
Manufacturer: Lappset UK Ltd

Finding: The fall height of the item exceeds 1.5m, grass is not deemed a suitable impact absorbing surface for fall heights in excess of 1.5m

Action: Consider providing a suitable impact absorbing surface

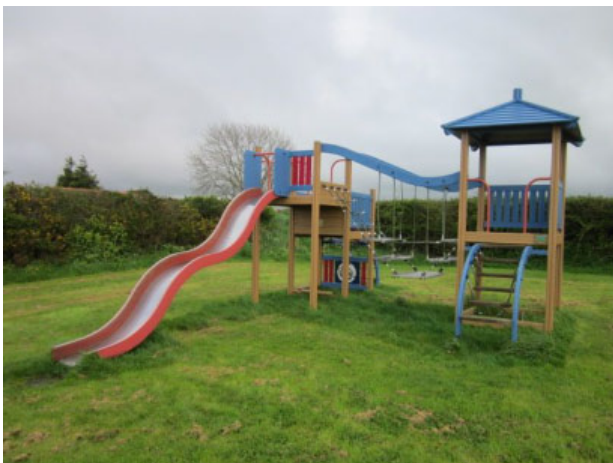
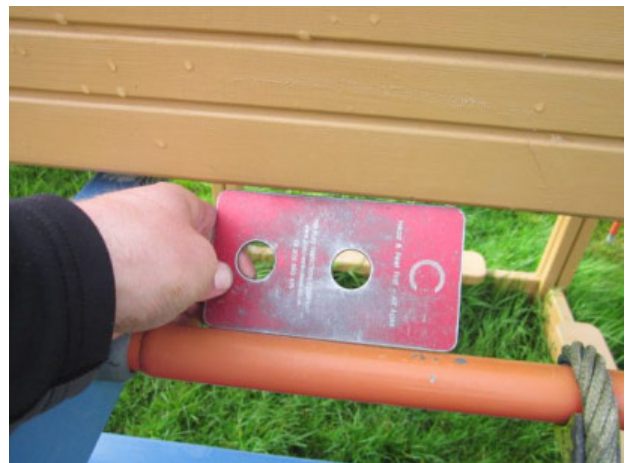
Item: Agility - Multi Play
Manufacturer: Lappset UK Ltd

Finding: The item fails to meet the requirements for head and neck entrapment at the top of the net climber and above the top swinging step BS EN 1176 Part 1

Action: Monitor use

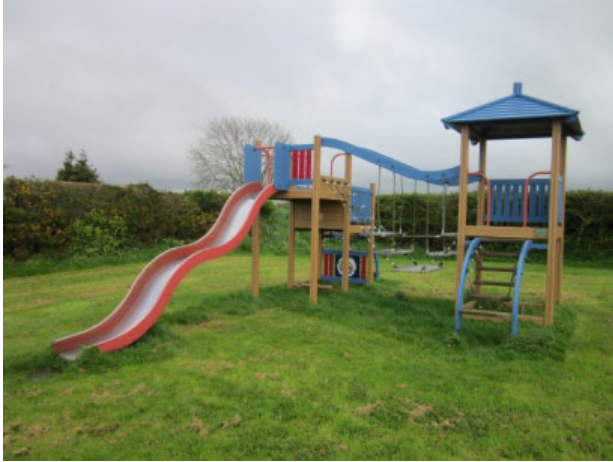
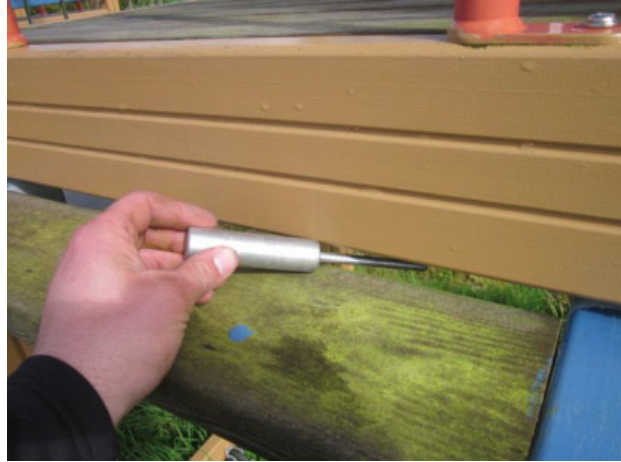
Item: Agility - Multi Play
Manufacturer: Lappset UK Ltd

Finding: There is a finger entrapment between the platform and the step above the swinging steps

Action: Remove entrapment

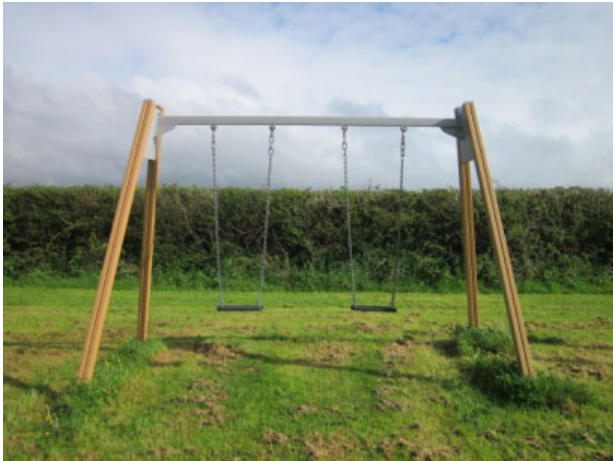
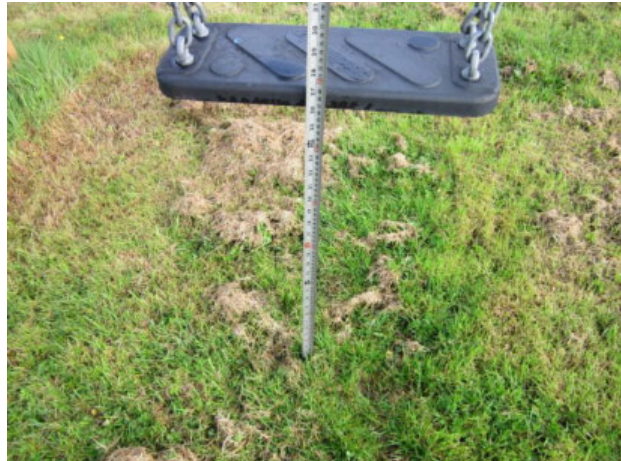
Item: Swings - 1 Bay 2 Seat (flat)
Manufacturer: Lappset UK Ltd

Finding: The seat heights are in excess of the recommended 635mm seat height

Action: Consider lowering the seats

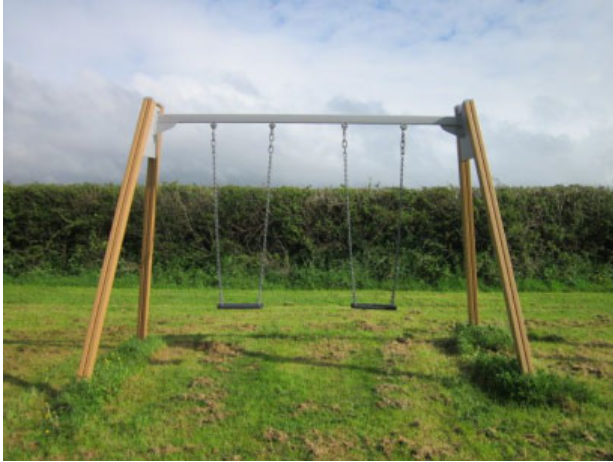
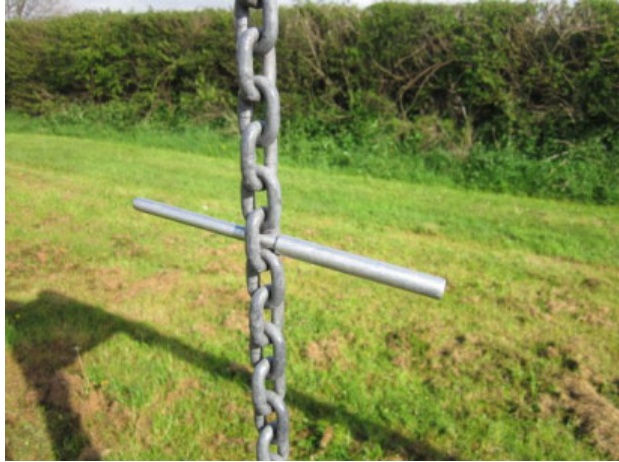
Item: Swings - 1 Bay 2 Seat (flat)
Manufacturer: Lappset UK Ltd

Finding: The chain openings are in excess of the 8.6mm recommended by BS EN 1176

Action: Monitor use and replace with compliant chains during next maintenance cycle.

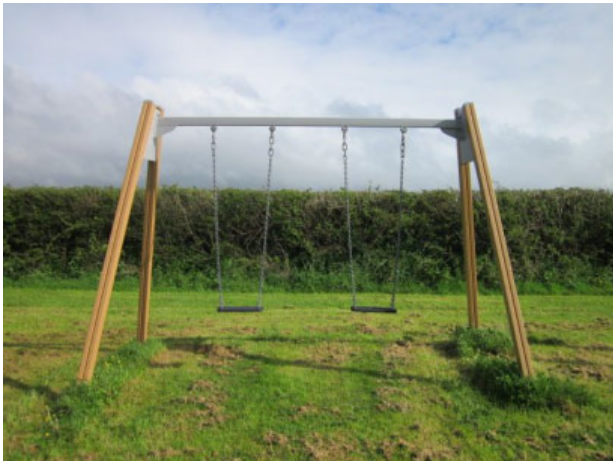
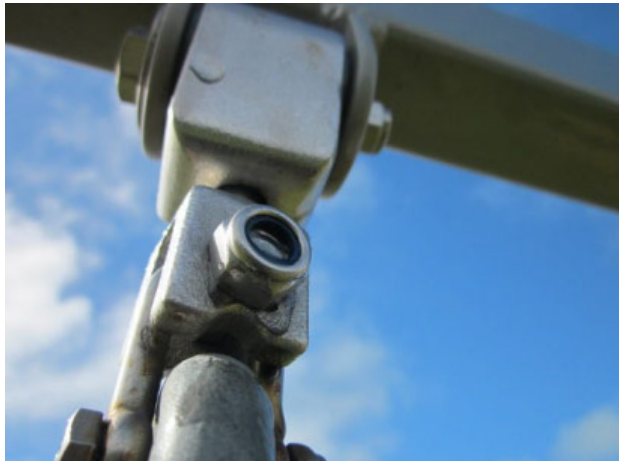
Item: Swings - 1 Bay 2 Seat (flat)
Manufacturer: Lappset UK Ltd

Finding: There is a pivot block fixing bolt that is not fully inserted into the nylok nut

Action: Adjust

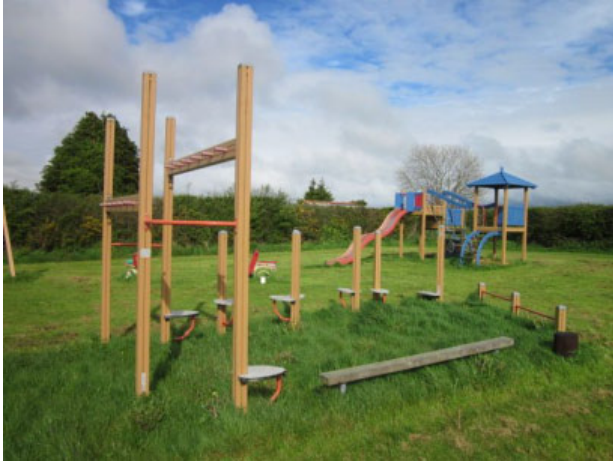
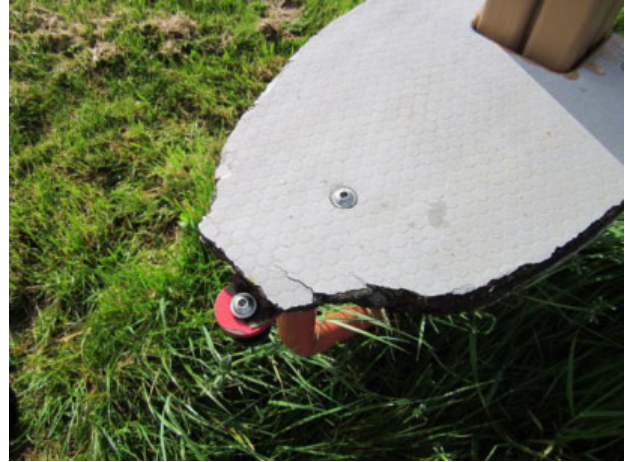
Item: Other - Adventure Trail
Manufacturer: Lappset UK Ltd

Finding: There is some damage to one of the platforms

Action: Replace the damaged platform

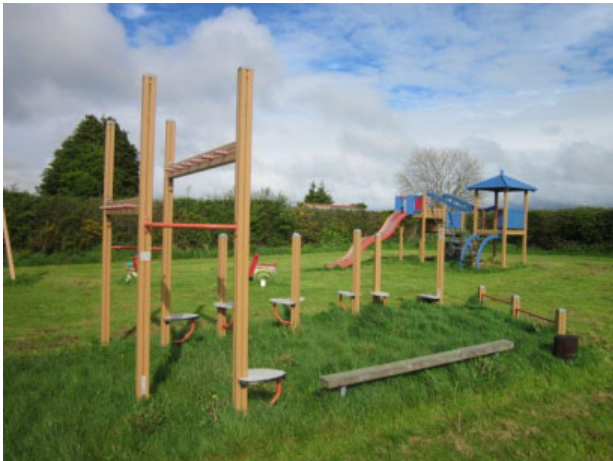
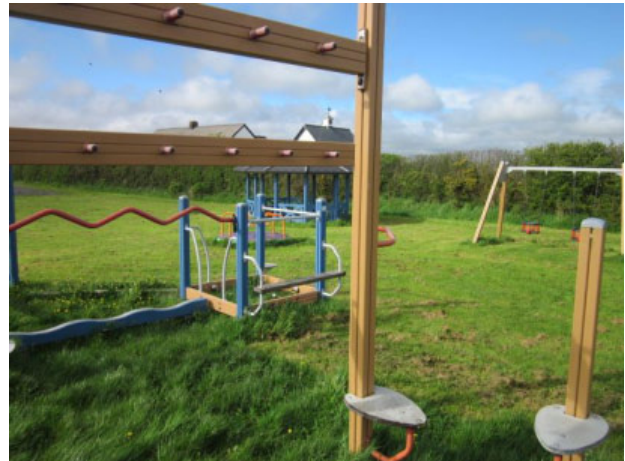
Item: Other - Adventure Trail
Manufacturer: Lappset UK Ltd

Finding: There are platforms in the falling space of the overhead grips

Action: Monitor use

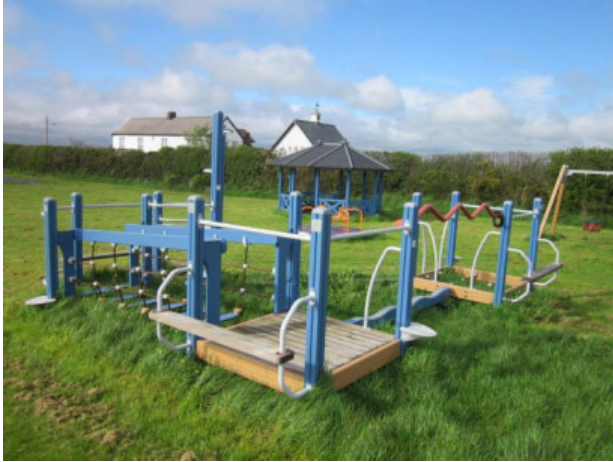
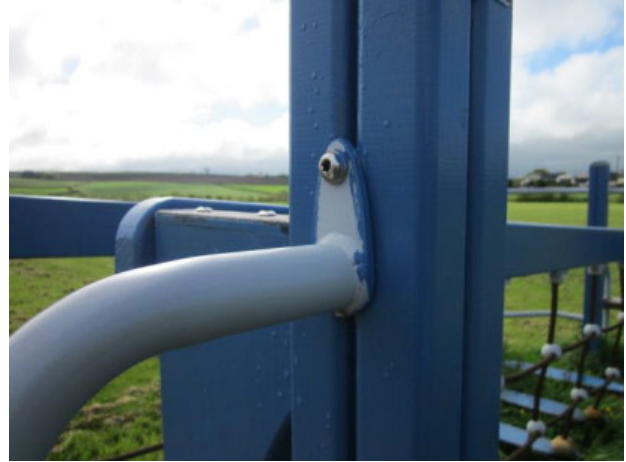
Item: Other - Fitness Trail
Manufacturer: Lappset UK Ltd

Finding: There are some loose fixings between items in the trail and the posts

Action: Secure loose fixings

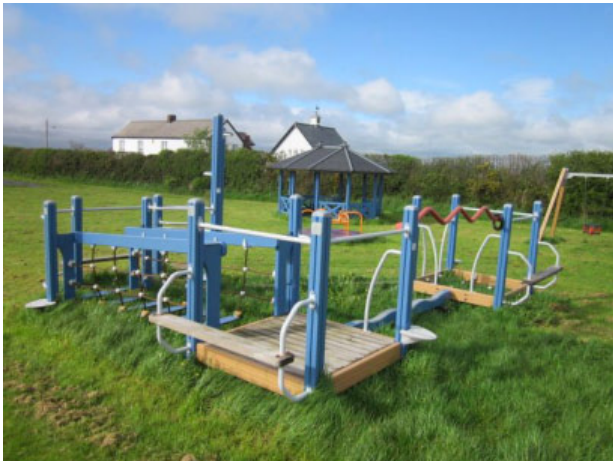
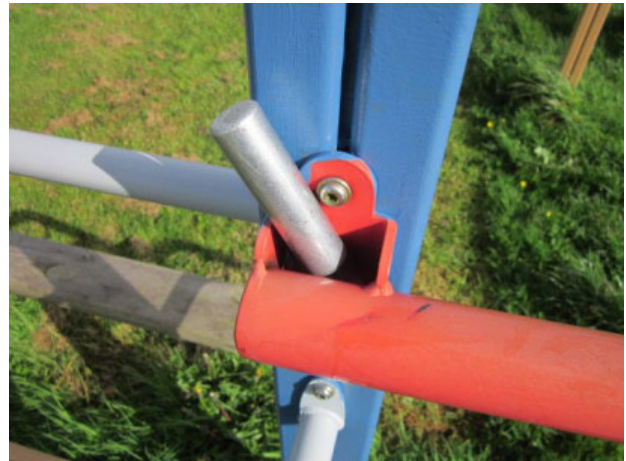
Item: Other - Fitness Trail
Manufacturer: Lappset UK Ltd

Finding: There are finger entrapments in the zig zag beam ends

Action: Remove entrapments

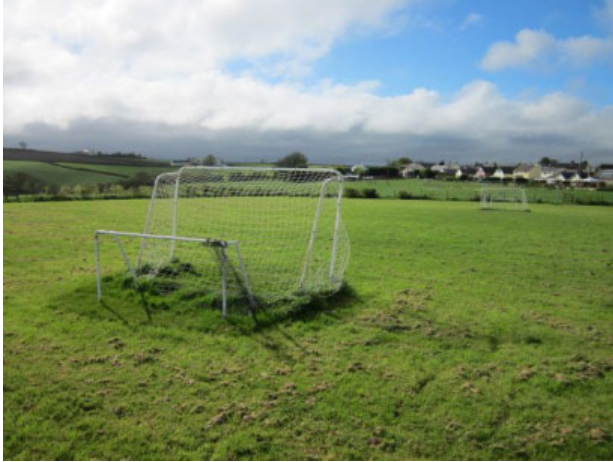
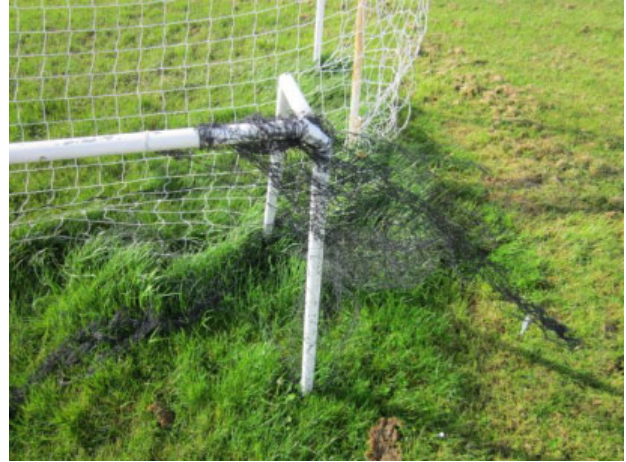
Item: Other - Football Goal
Manufacturer: Unknown

Finding: The nets on the goals are loose and damaged

Action: Repair and secure

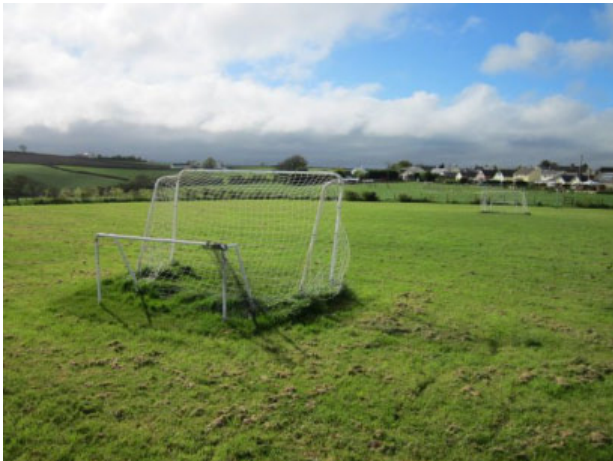
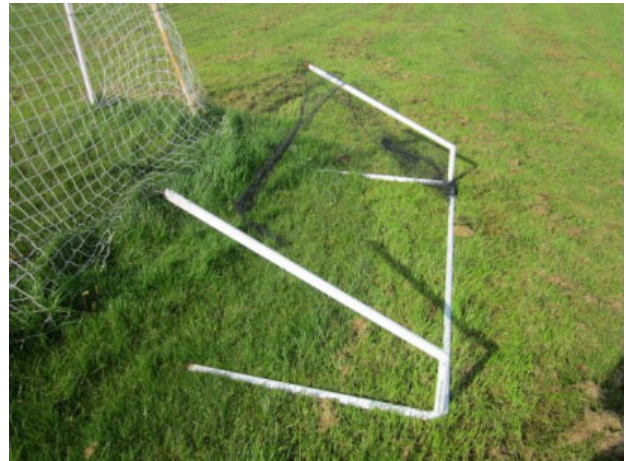
Item: Other - Football Goal
Manufacturer: Unknown

Finding: The goals are not secured in the ground, they are leaning and can be tipped over

Action: Secure the goals in position

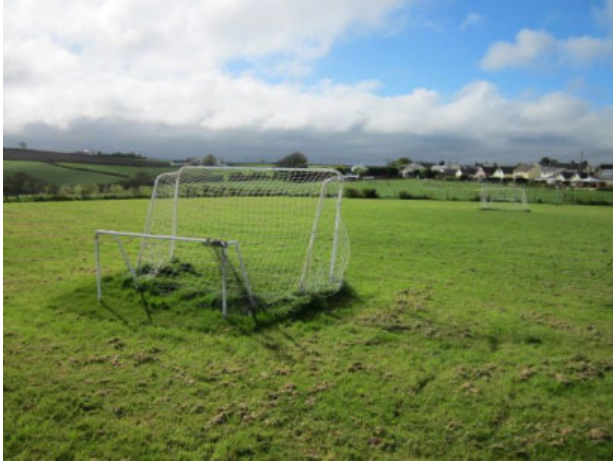
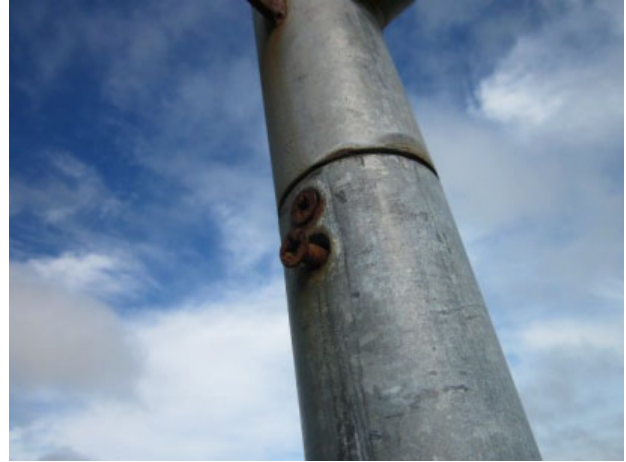
Item: Other - Football Goal
Manufacturer: Unknown

Finding: There are some loose fixings to the goal frames

Action: Secure loose fixings
