## Annual Inspection

TK Play

Frithelstock Parish Playing Fields

Annual Inspection - 13 May 2016 at 11:21 Inspector: Dr. Jody Chilton RPII Annual Inspector

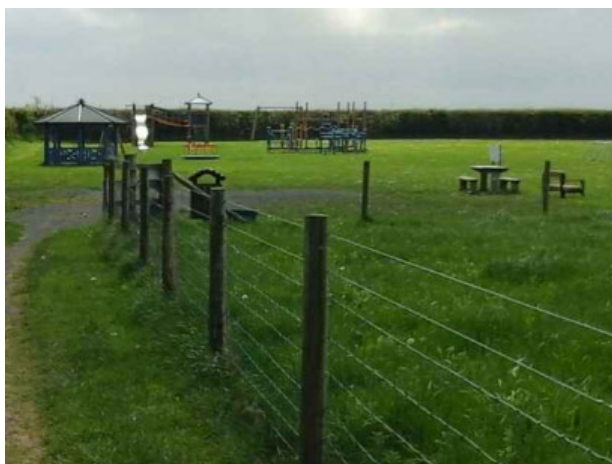
**Item:** Ancillary Items - Site General  
**Manufacturer:** Unknown  
**Surface Type:** N/A  
**Equipment Compliance:** N/A  
**Surface Area Compliance:** N/A  
**Ref/Part Number:**  
**Total Findings:** 1

There is some strimmer damage apparent on the posts, this can penetrate the preservative applied to the timber and accelerate the rotting process - Monitor for any deterioration (rot) and replace as required

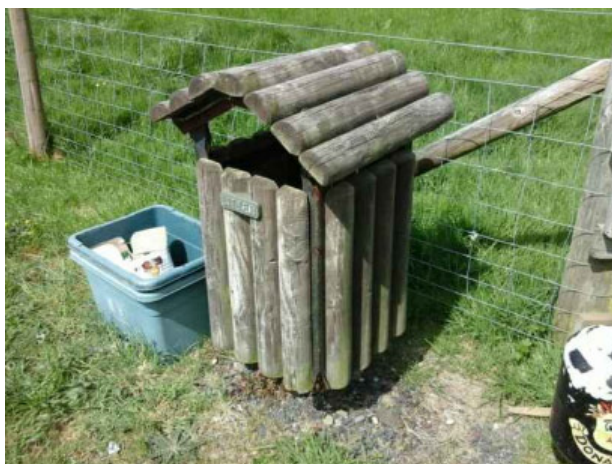
**Item:** Ancillary Items - Litter Bin  
**Manufacturer:** Unknown  
**Surface Type:** N/A  
**Equipment Compliance:** N/A  
**Surface Area Compliance:** N/A  
**Ref/Part Number:**  
**Total Findings:** 2

The paintwork on this item has been damaged or worn exposing the metal underneath which is rusting - Treat any rusting components and repaint

There is a box of bottles present - Remove

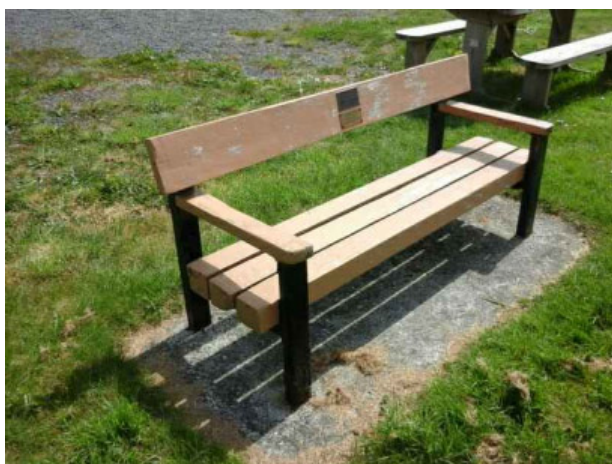
**Item:** Ancillary Items - Bench  
**Manufacturer:** Unknown  
**Surface Type:** N/A  
**Equipment Compliance:** N/A  
**Surface Area Compliance:** N/A  
**Ref/Part Number:**  
**Total Findings:** 2

The timber stain is in poor condition - Prepare all affected parts and re-stain with an appropriate preservative

There is some evidence of rot in the timber - Monitor for any further deterioration and replace as required

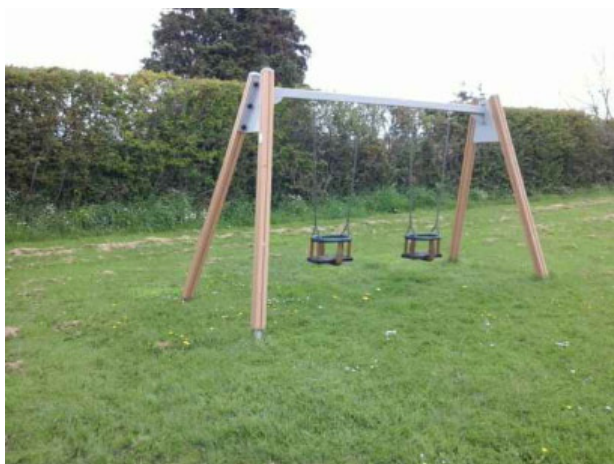
**Item:** Swings - 1 Bay 2 Seat (Cradle)  
**Manufacturer:** Lappset UK Ltd  
**Surface Type:** Grass  
**Equipment Compliance:** No  
**Surface Area Compliance:** Yes  
**Ref/Part Number:**  
**Total Findings:** 4

There is/are bolt cap covers missing or damaged on the item - Replace missing or damaged bolt cap covers

There is minor damage to a support post around the foot mount - Monitor for any further deterioration and repair as required

The chain openings are in excess of the 8.6mm as recommended by BS EN 1176 - Monitor use and replace with compliant chains during next maintenance cycle.

There is some chain wear - Monitor for any further deterioration and replace when 40% worn

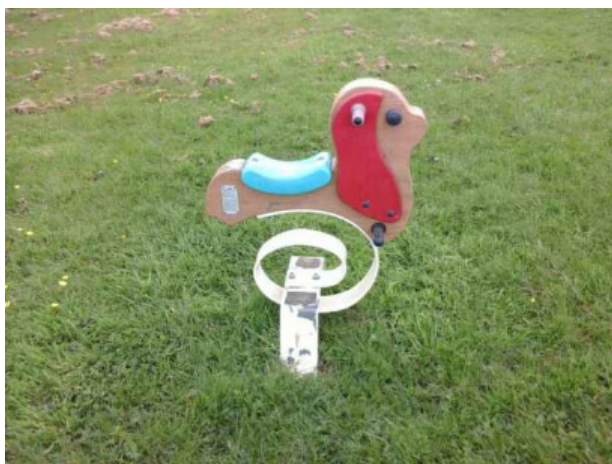
**Item:** Rocking Equipment - Spring Dog  
**Manufacturer:** Lappset UK Ltd  
**Surface Type:** Grass  
**Equipment Compliance:** No  
**Surface Area Compliance:** Yes  
**Ref/Part Number:**  
**Total Findings:** 4

The end of handgrips and/or footrests have a cross section of less than 15cm<sup>2</sup> and fail to meet the requirements of BS EN 1176:2008 Part 6 - This is a relatively low risk failure and no remedial action is recommended

The plywood has delaminated in some places - Remove all rough or splintered edges.

There is minor damage to the seat - Monitor for any further deterioration and repair as required

The timber stain is in poor condition - Prepare all affected parts and re-stain with an appropriate preservative

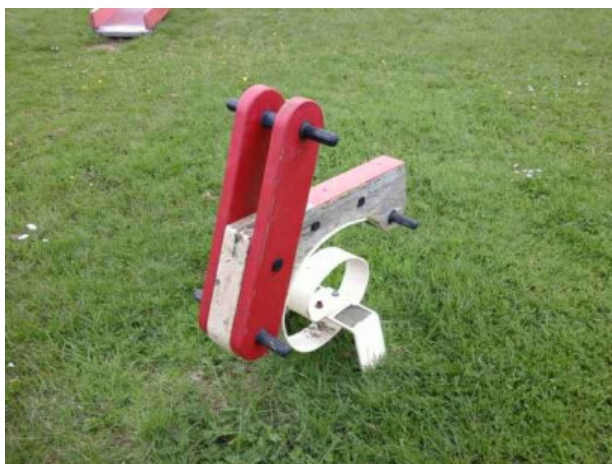
**Item:** Rocking Equipment - Spring Bike  
**Manufacturer:** Lappset UK Ltd  
**Surface Type:** Grass  
**Equipment Compliance:** No  
**Surface Area Compliance:** Yes  
**Ref/Part Number:**  
**Total Findings:** 4

The end of handgrips and/or footrests have a cross section of less than 15cm<sup>2</sup> and fail to meet the requirements of BS EN 1176:2008 Part 6 - This is a relatively low risk failure and no remedial action is recommended

The seat is missing - Replace the seat

There is some evidence of rot in the timber - Monitor for any further deterioration and replace as required

The timber stain is in poor condition - Prepare all affected parts and re-stain with an appropriate preservative

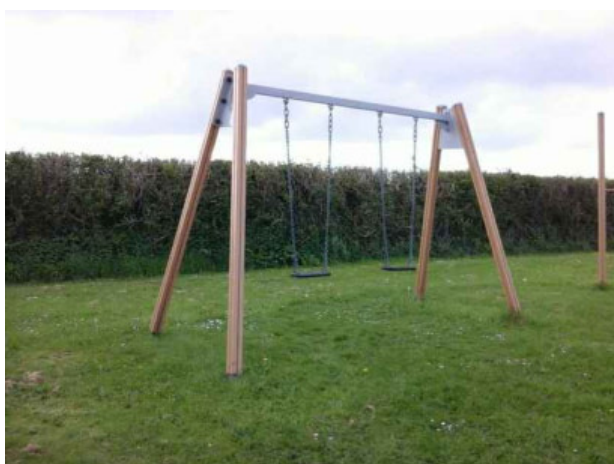
**Item:** Swings - 1 Bay 2 Seat (Flat)  
**Manufacturer:** Lappset UK Ltd  
**Surface Type:** Grass  
**Equipment Compliance:** No  
**Surface Area Compliance:** Yes  
**Ref/Part Number:**  
**Total Findings:** 7

There is/are bolt cap covers missing or damaged on the item - Replace missing or damaged bolt cap covers

There is minor damage to a post - Monitor for any further deterioration and replace as required

The seats are over 650mm high and may be difficult for some users to access - Consider lengthening the chains to lower the seats

The chain openings are in excess of the 8.6mm as recommended by BS EN 1176 - Monitor use and replace with compliant chains during next maintenance cycle.

There is some chain wear - Monitor for any further deterioration and replace when 40% worn

The seat has minor damage or wear - Monitor for any further deterioration and replace as required

The item of equipment has a fall height exceeding 1.50 metres and the grassmats have been buried potentially affecting their impact attenuating properties.  
- Lift and relay the mats or provide a new suitable impact attenuating surface

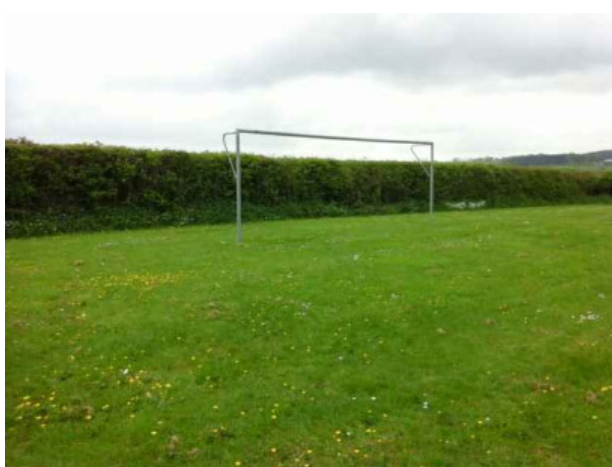
**Item:** Multi Use Games Area - Football Goal  
**Manufacturer:** Unknown  
**Surface Type:** Grass  
**Equipment Compliance:** N/A  
**Surface Area Compliance:** N/A  
**Ref/Part Number:**  
**Total Findings:** 4

The goals are slightly loose in their sockets - Monitor for any further deterioration and repair as required

The paintwork on this item has been damaged or worn exposing the metal underneath which is rusting - Treat any rusting components and repaint

The 5 a side goals and nets are not secured to the ground and there is some possibility of the item tipping over - Secure the goals

A number of fixing(s) have worked loose - Secure all loose fixings

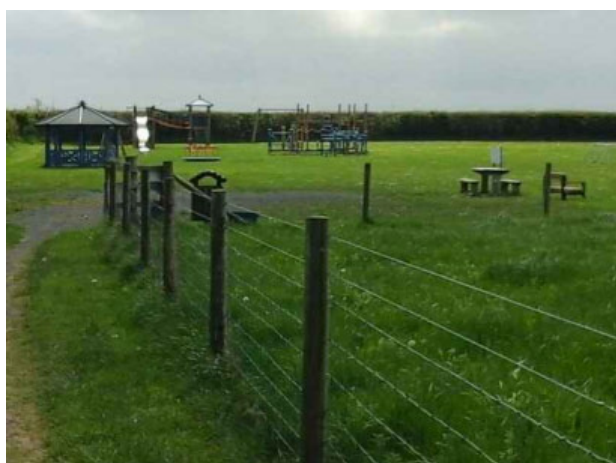
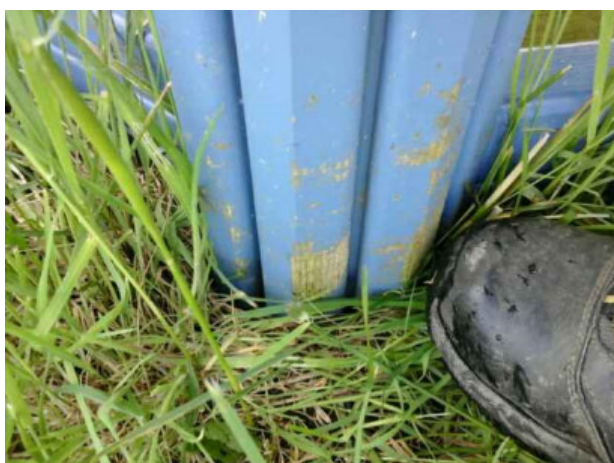
**Item:** Ancillary Items - Site General  
**Manufacturer:** Unknown

**Finding:** There is some strimmer damage apparent on the posts, this can penetrate the preservative applied to the timber and accelerate the rotting process

**Action:** Monitor for any deterioration (rot) and replace as required

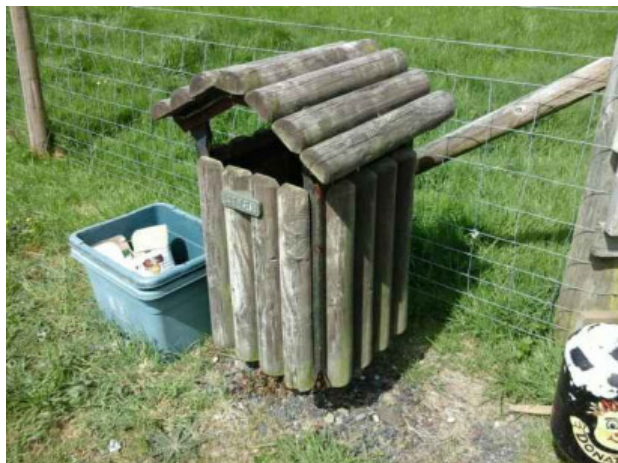
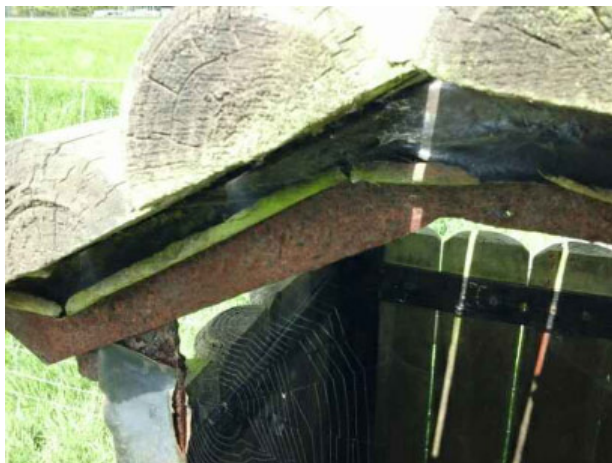
**Item:** Ancillary Items - Litter Bin  
**Manufacturer:** Unknown

**Finding:** The paintwork on this item has been damaged or worn exposing the metal underneath which is rusting

**Action:** Treat any rusting components and repaint

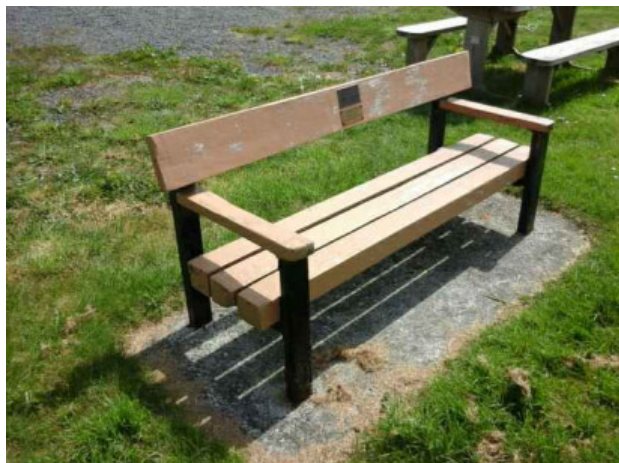
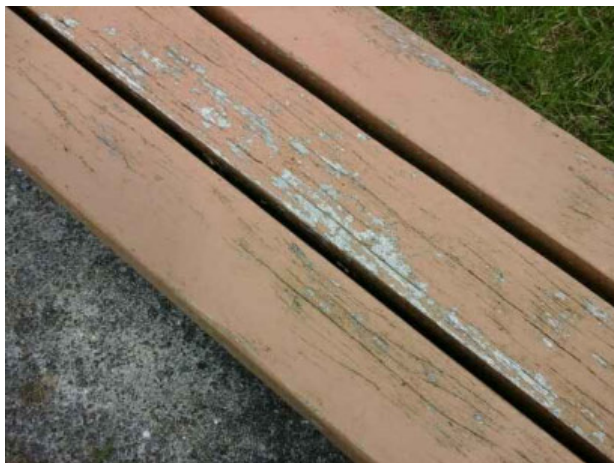
**Item:** Ancillary Items - Bench  
**Manufacturer:** Unknown

**Finding:** The timber stain is in poor condition

**Action:** Prepare all affected parts and re-stain with an appropriate preservative

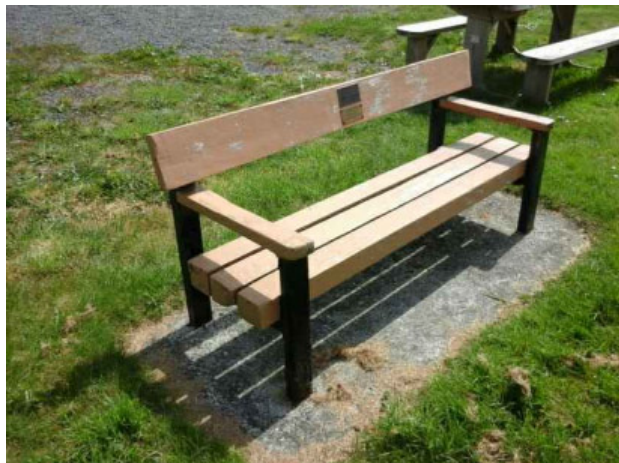
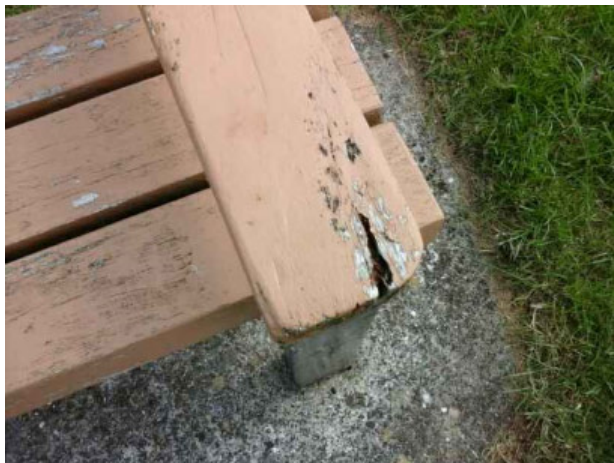
**Item:** Ancillary Items - Bench  
**Manufacturer:** Unknown

**Finding:** There is some evidence of rot in the timber

**Action:** Monitor for any further deterioration and replace as required

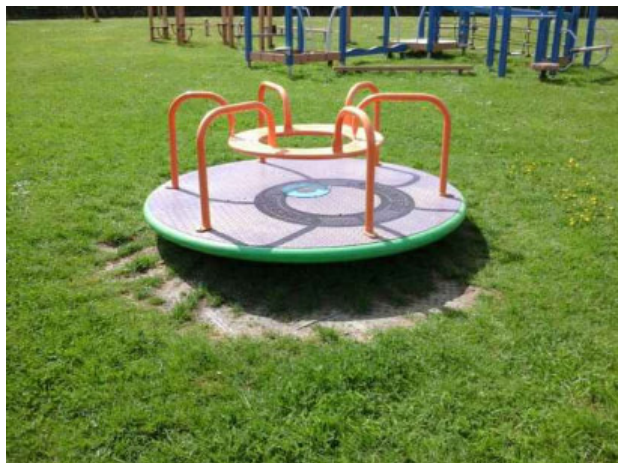
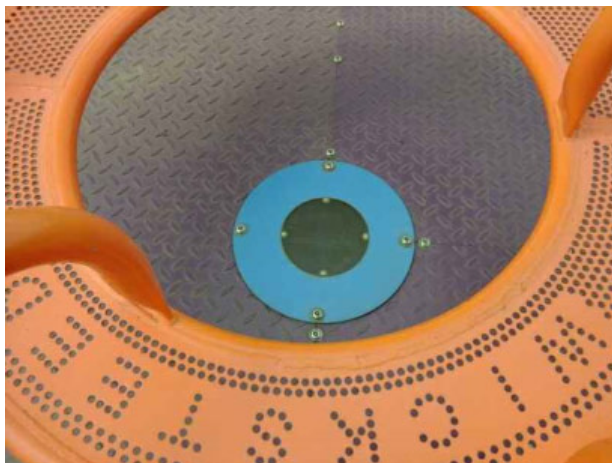
**Finding:** The bearing is worn and has excessive lateral play

**Action:** Replace the bearing as required

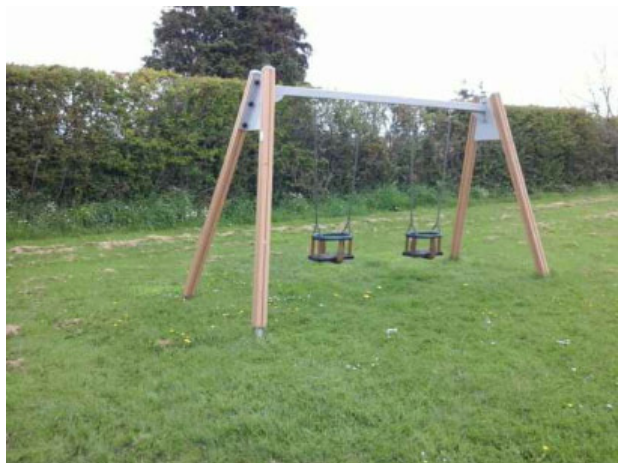
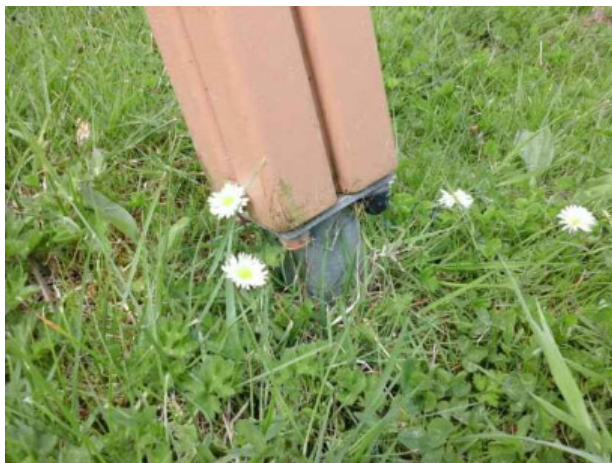
**Finding:** There is/are bolt cap covers missing or damaged on the item

**Action:** Replace missing or damaged bolt cap covers

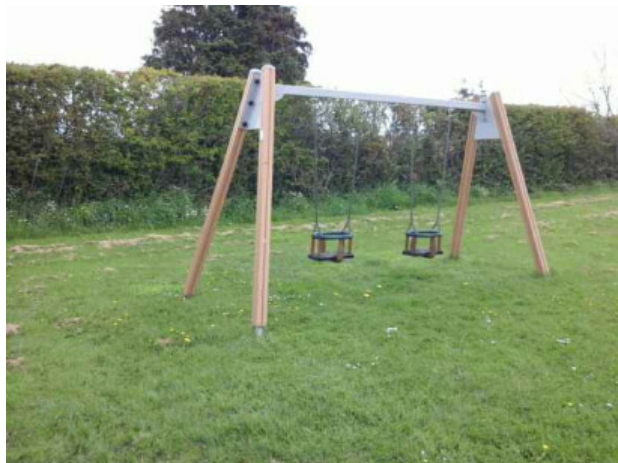
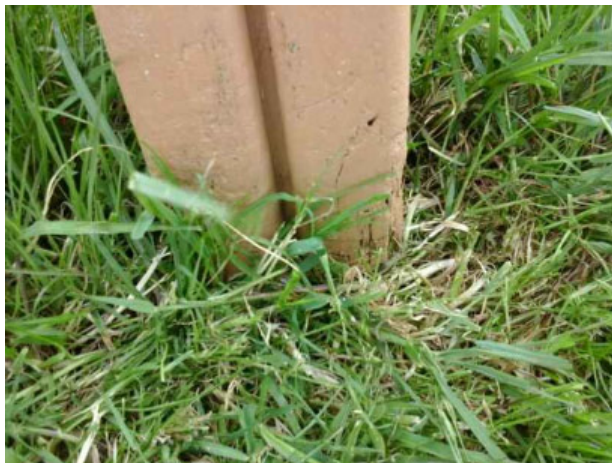
**Finding:** There is minor damage to a support post around the foot mount

**Action:** Monitor for any further deterioration and repair as required

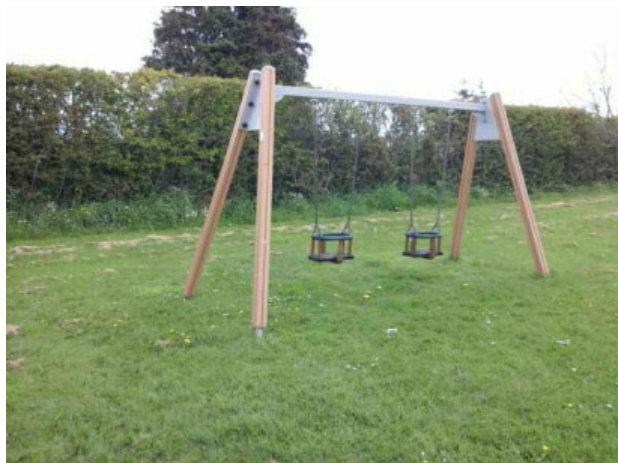
**Finding:** The chain openings are in excess of the 8.6mm as recommended by BS EN 1176

**Action:** Monitor use and replace with compliant chains during next maintenance cycle.

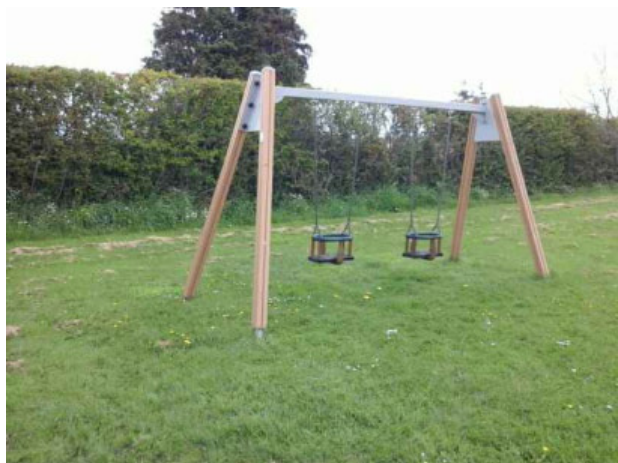
**Finding:** There is some chain wear

**Action:** Monitor for any further deterioration and replace when 40% worn

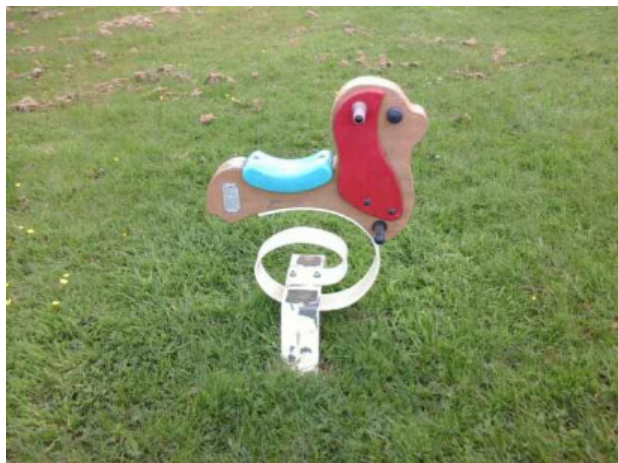
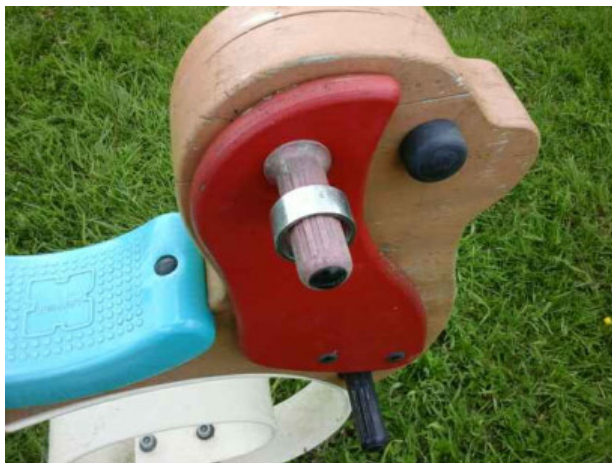
**Finding:** The end of handgrips and/or footrests have a cross section of less than 15cm<sup>2</sup> and fail to meet the requirements of BS EN 1176:2008 Part 6

**Action:** This is a relatively low risk failure and no remedial action is recommended

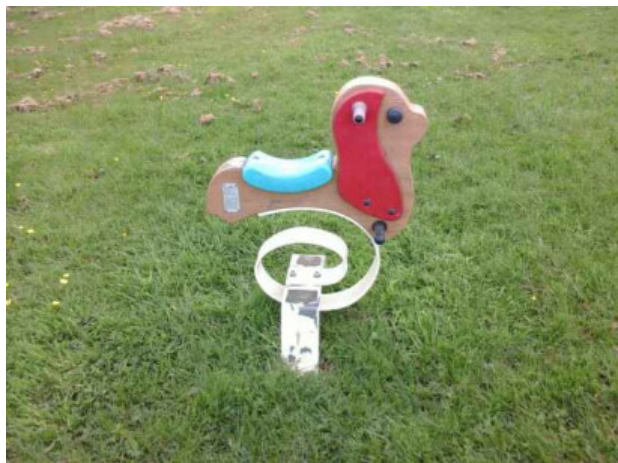
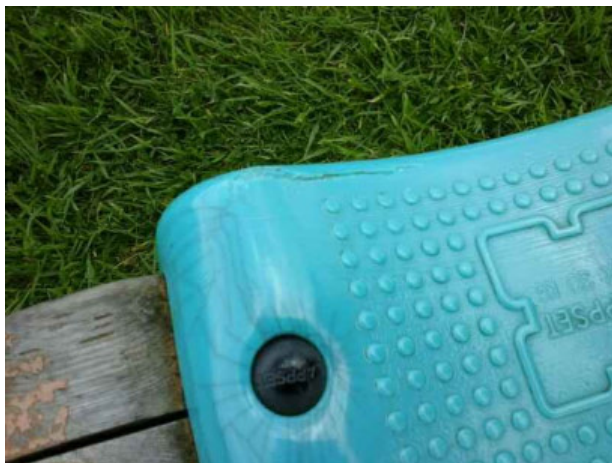
**Finding:** There is minor damage to the seat

**Action:** Monitor for any further deterioration and repair as required

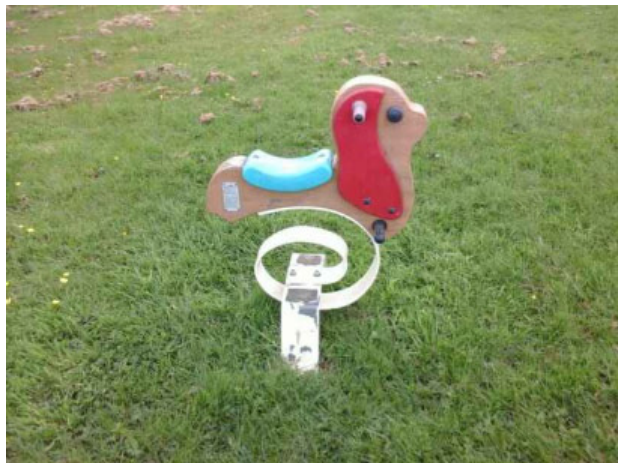
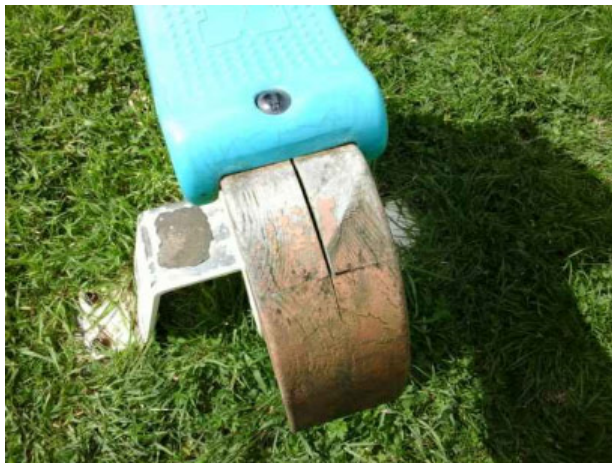
**Finding:** The timber stain is in poor condition

**Action:** Prepare all affected parts and re-stain with an appropriate preservative

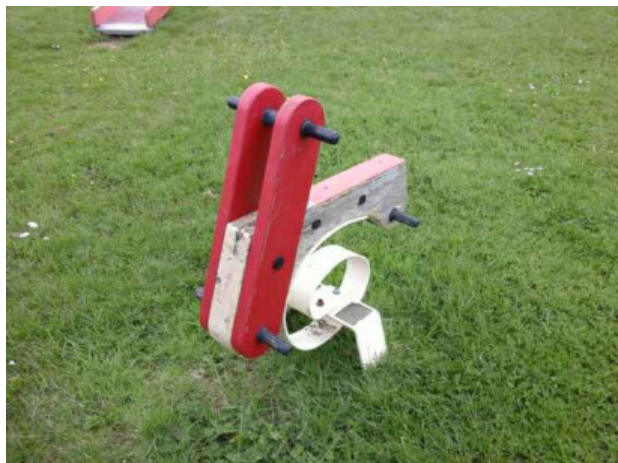
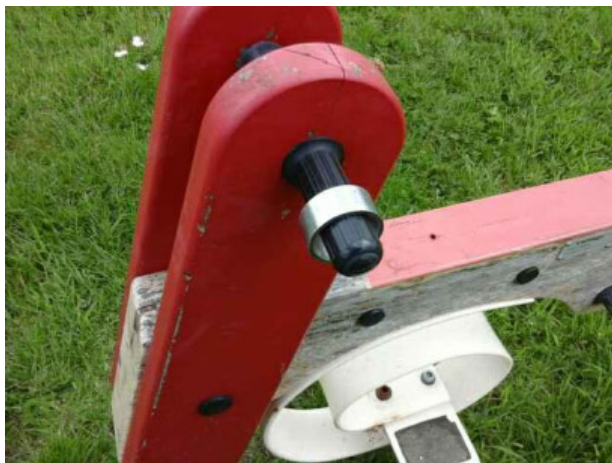
**Finding:** The end of handgrips and/or footrests have a cross section of less than 15cm<sup>2</sup> and fail to meet the requirements of BS EN 1176:2008 Part 6

**Action:** This is a relatively low risk failure and no remedial action is recommended

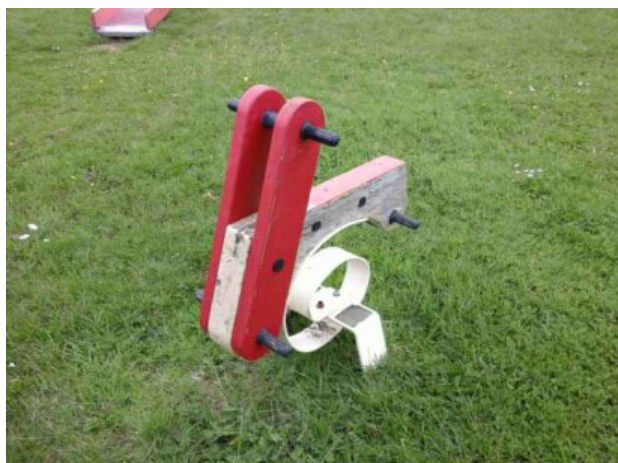
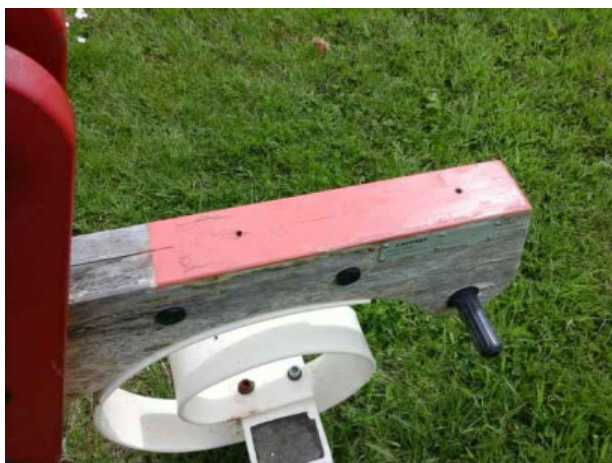
**Finding:** The seat is missing

**Action:** Replace the seat

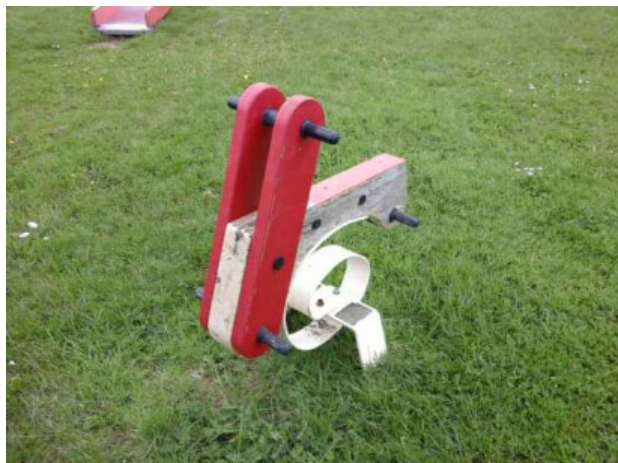
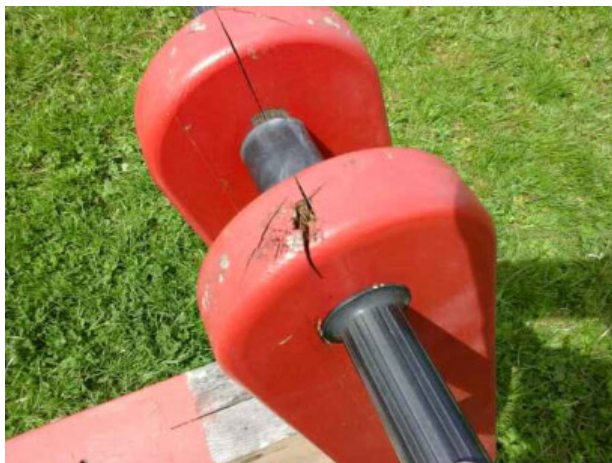
**Finding:** There is some evidence of rot in the timber

**Action:** Monitor for any further deterioration and replace as required

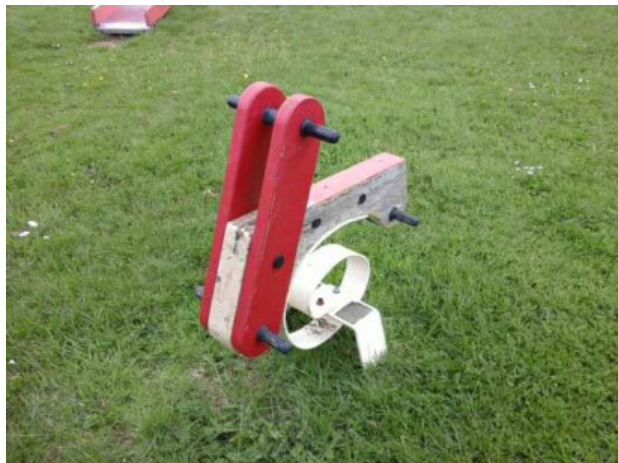
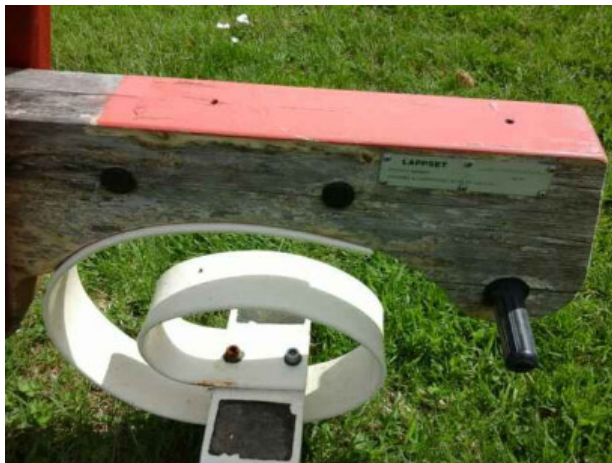
**Finding:** The timber stain is in poor condition

**Action:** Prepare all affected parts and re-stain with an appropriate preservative

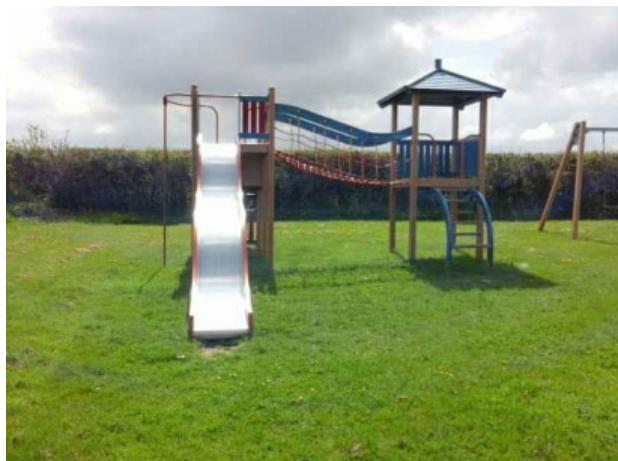
**Finding:** The item fails to meet the requirements of BS EN 1176:2008 Part 1 4.2.7.2 for head and neck entrapment in the curved access net

**Action:** Monitor use

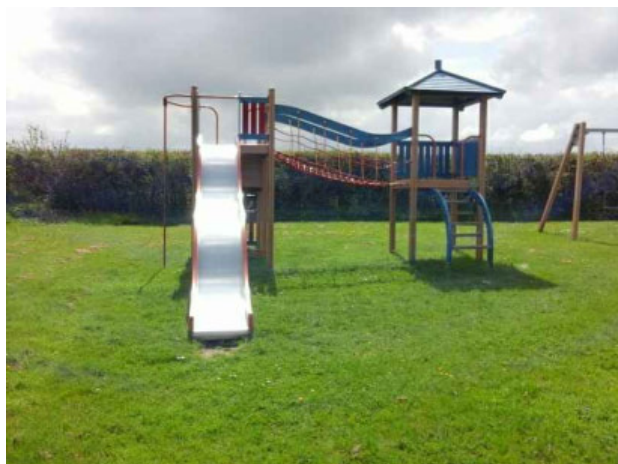
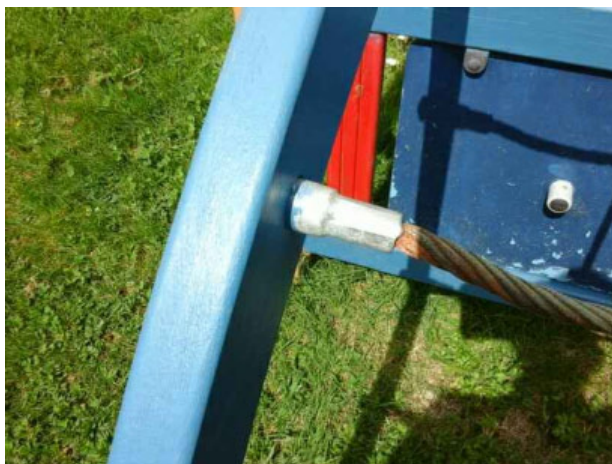
**Finding:** A number of rope fixing(s) have worked loose

**Action:** Secure all loose fixings

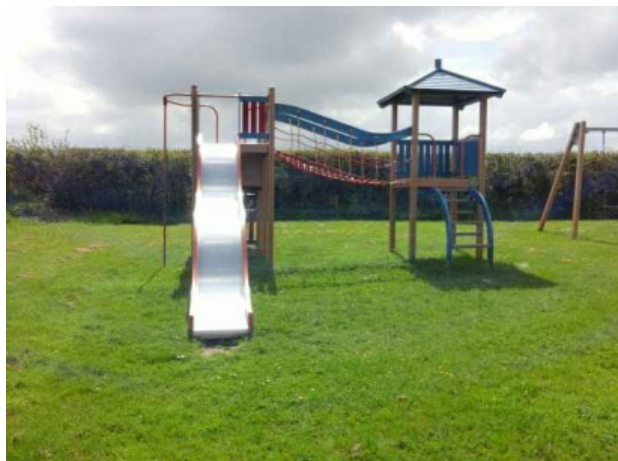
**Finding:** There is/are bolt cap covers missing or damaged on the item

**Action:** Replace missing or damaged bolt cap covers

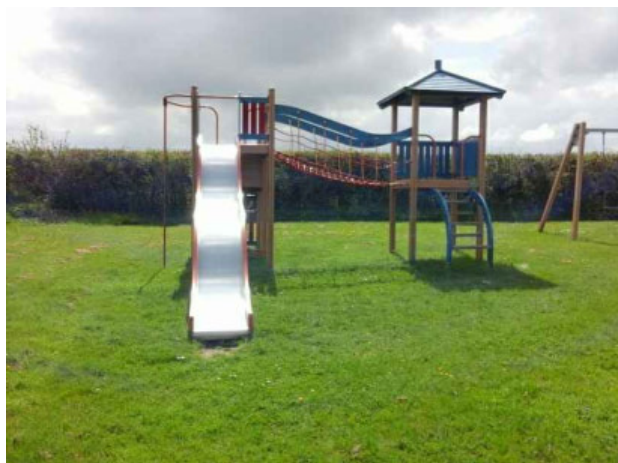
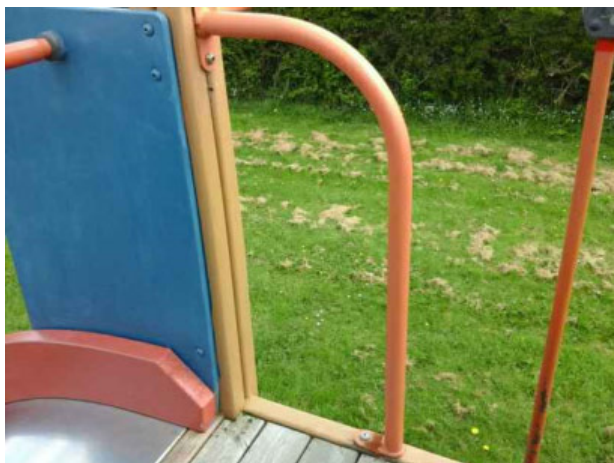
**Finding:** A number of handrail fixing(s) have worked loose throughout the unit

**Action:** Secure all loose fixings

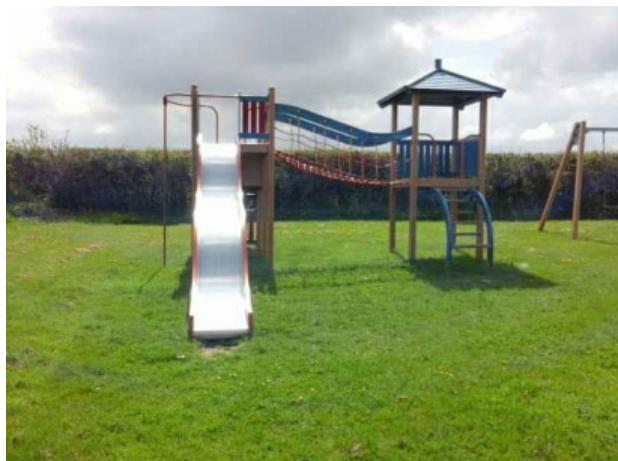
**Finding:** There is/are finger entrapment/s in the platform at the top of the slide and the item fails to meet the requirements of BS EN 1176:2008 Part 1 4.2.7.6 Entrapment of fingers

**Action:** Monitor use

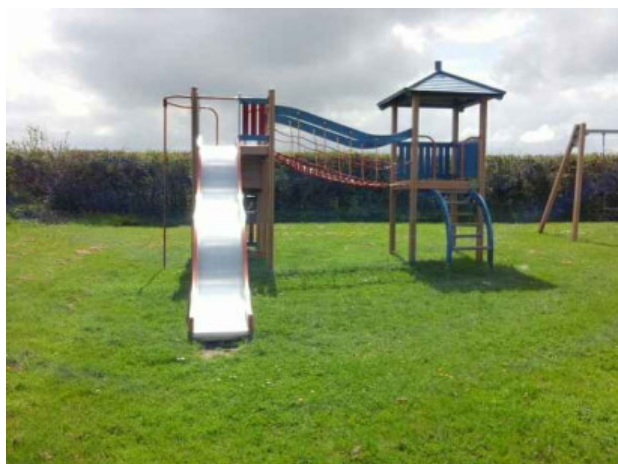
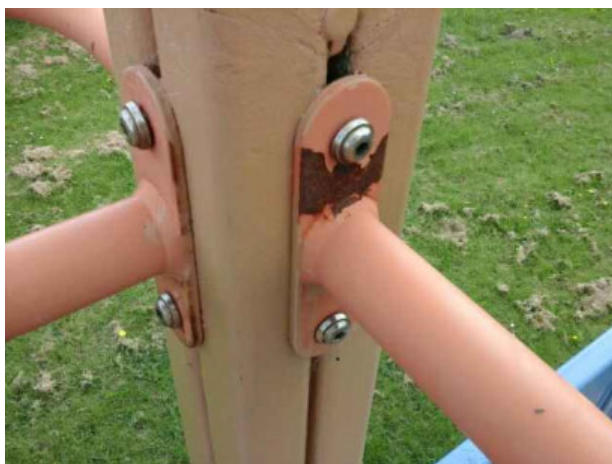
**Finding:** The paintwork on this item has been damaged or worn exposing the metal underneath which is rusting

**Action:** Treat any rusting components and repaint

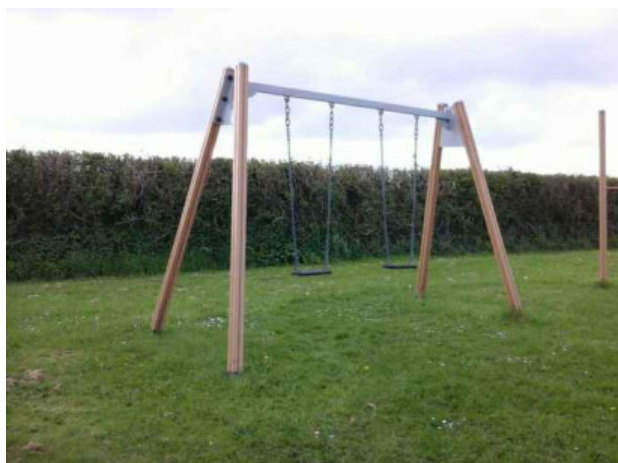
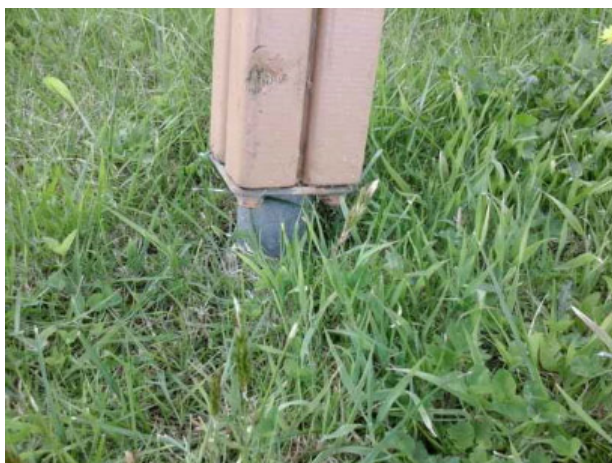
**Finding:** There is/are bolt cap covers missing or damaged on the item

**Action:** Replace missing or damaged bolt cap covers

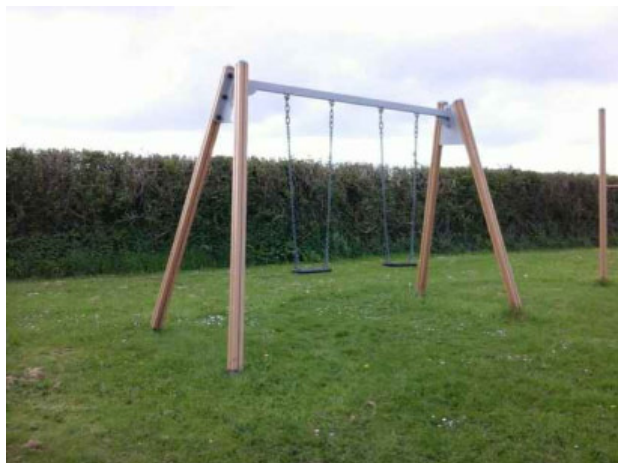
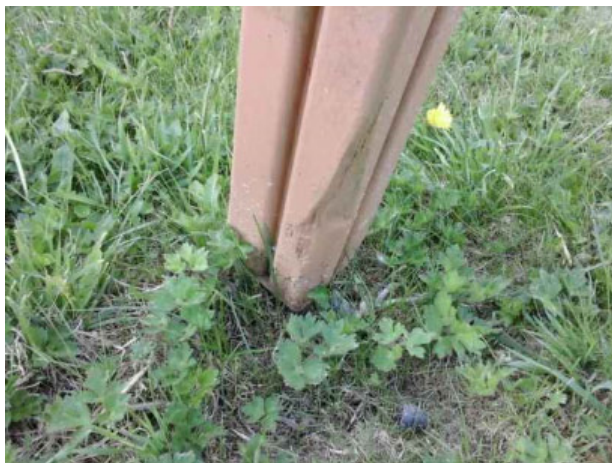
**Finding:** There is minor damage to a post

**Action:** Monitor for any further deterioration and replace as required

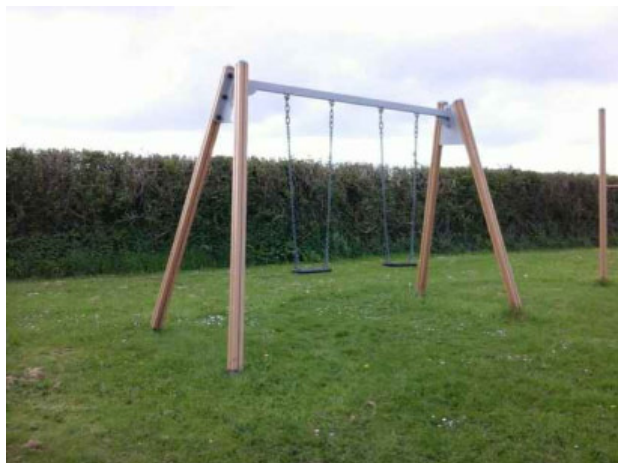
**Finding:** The chain openings are in excess of the 8.6mm as recommended by BS EN 1176

**Action:** Monitor use and replace with compliant chains during next maintenance cycle.

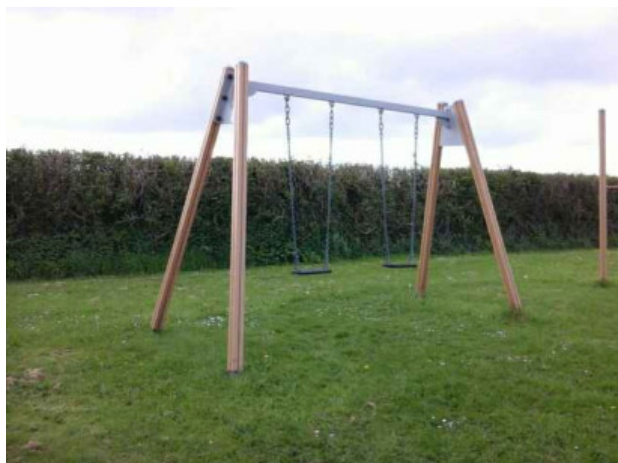
**Finding:** There is some chain wear

**Action:** Monitor for any further deterioration and replace when 40% worn

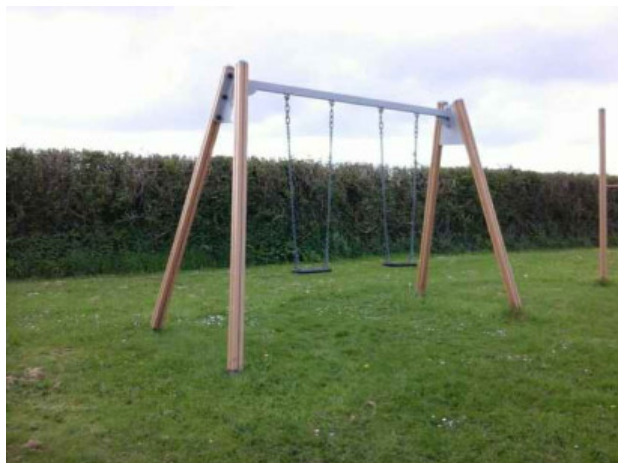
**Finding:** The seat has minor damage or wear

**Action:** Monitor for any further deterioration and replace as required

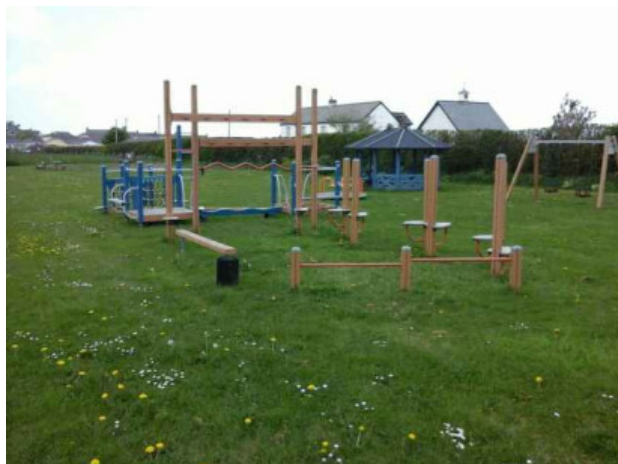
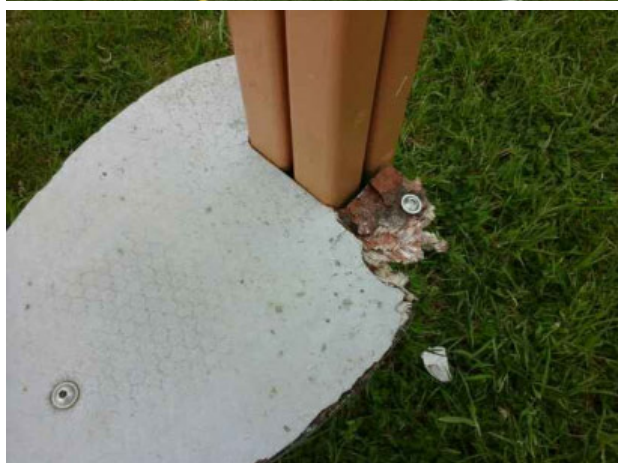
**Risk Level:** M - Moderate Risk  
**Surface:** Grass

**Finding:** There are areas or parts of the timber stilt platforms on the structure that have rotted around fixing points

**Action:** Replace all affected timbers

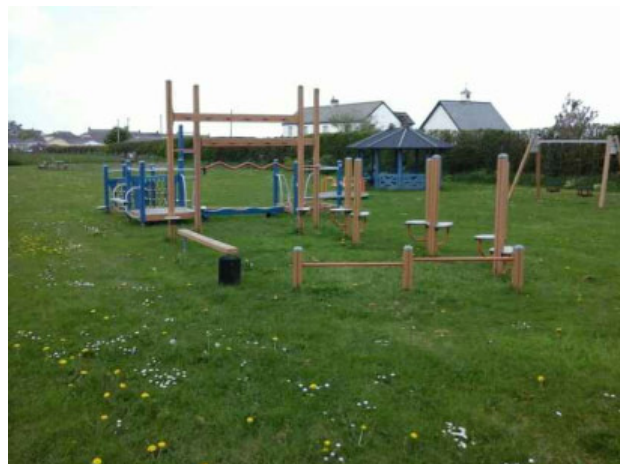
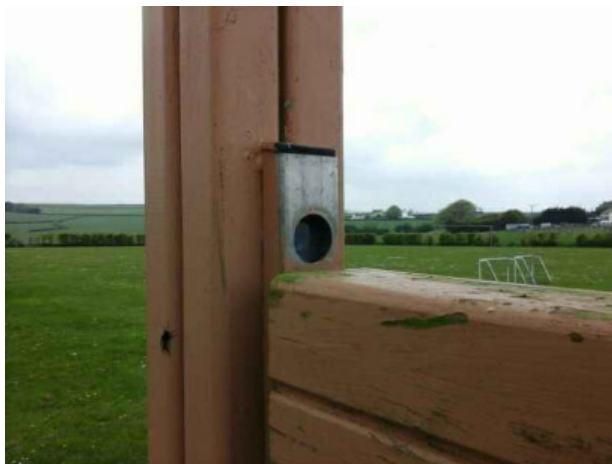
**Finding:** There is/are several inserts missing

**Action:** Replace missing inserts

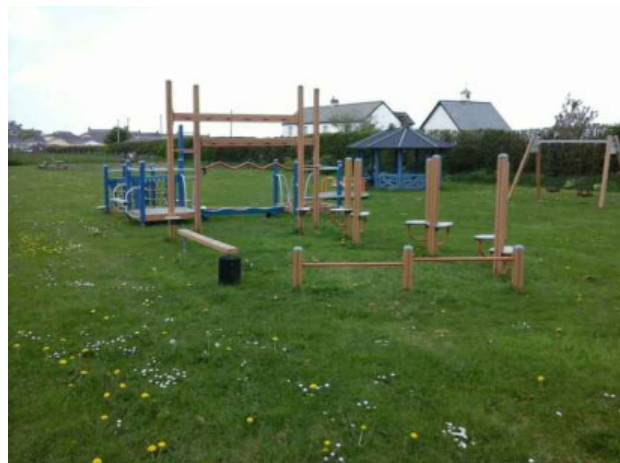
**Finding:** A number of fixing(s) have worked loose

**Action:** Secure all loose fixings

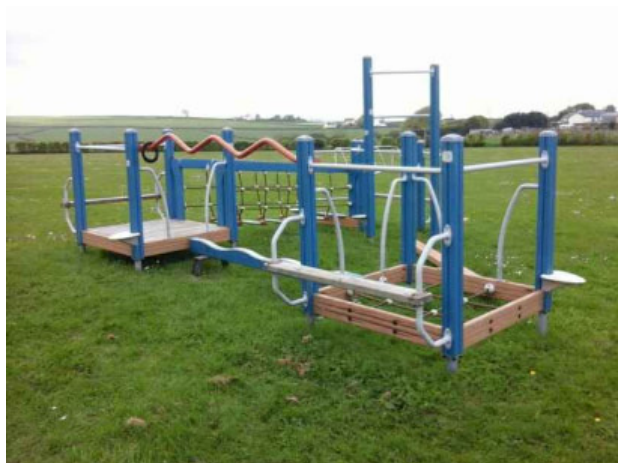
**Finding:** A number of handle fixing(s) have worked loose

**Action:** Secure all loose fixings

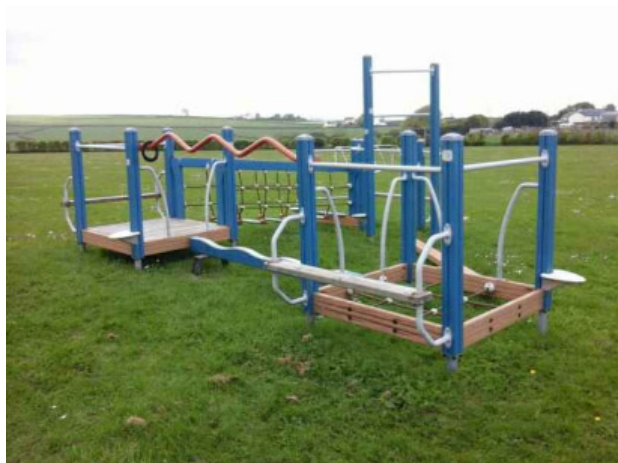
**Finding:** There is/are several inserts missing

**Action:** Replace missing inserts

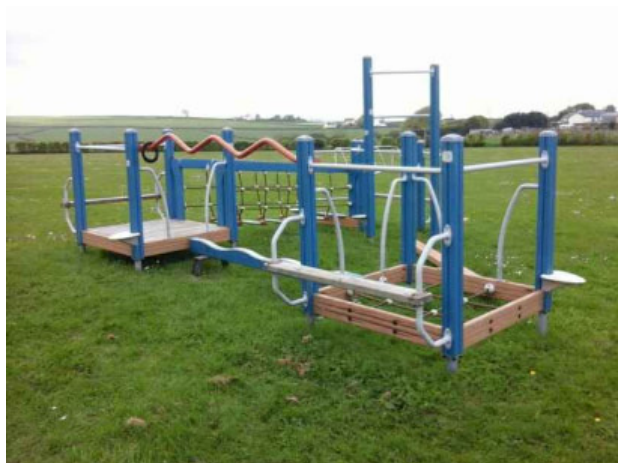
**Finding:** The paintwork on this item has been damaged or worn exposing the metal underneath which is rusting

**Action:** Treat any rusting components and repaint

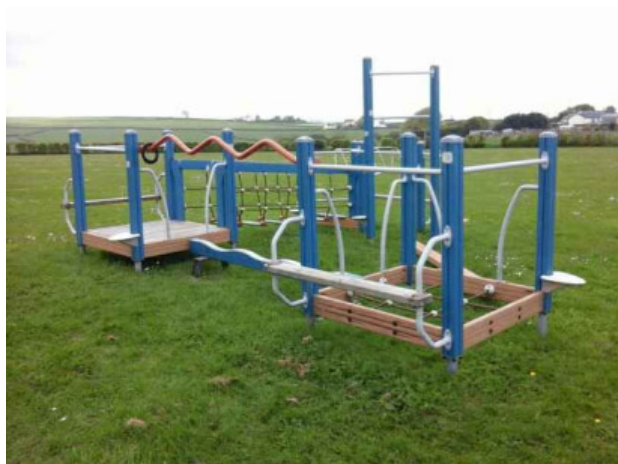
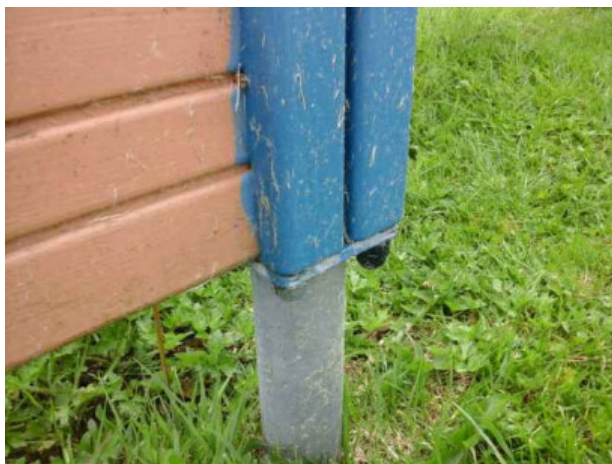
**Finding:** There is/are bolt cap covers missing or damaged on the item

**Action:** Replace missing or damaged bolt cap covers

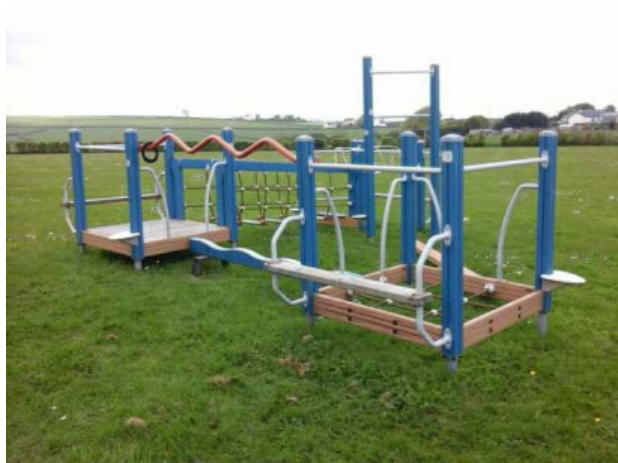
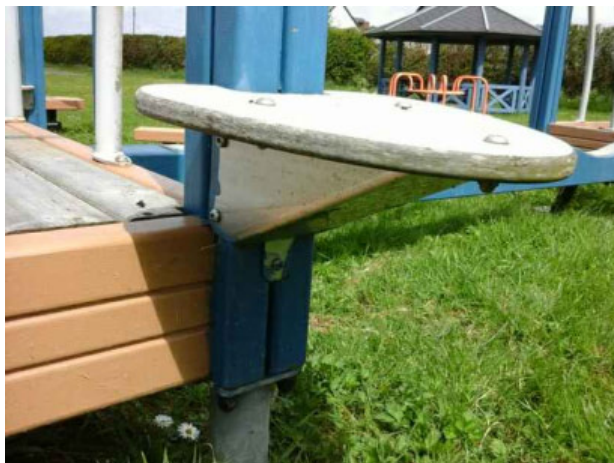
**Finding:** A number of footplate fixing(s) have worked loose

**Action:** Secure all loose fixings

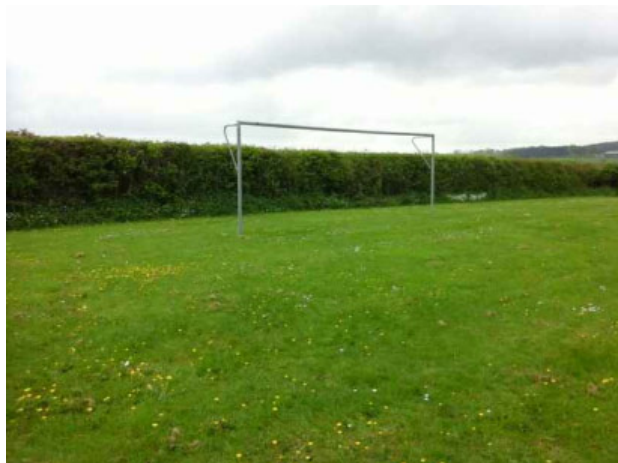
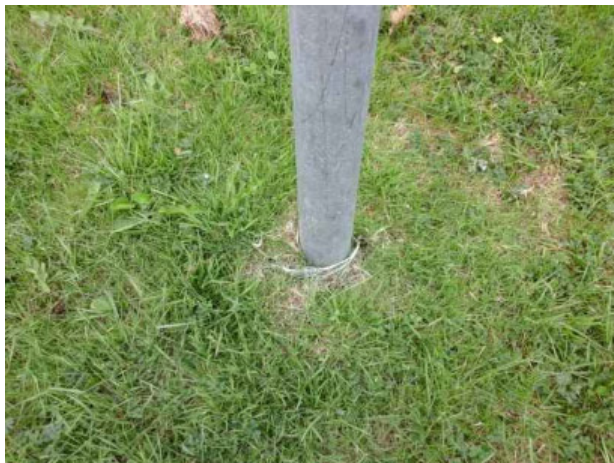
**Finding:** The goals are slightly loose in their sockets

**Action:** Monitor for any further deterioration and repair as required

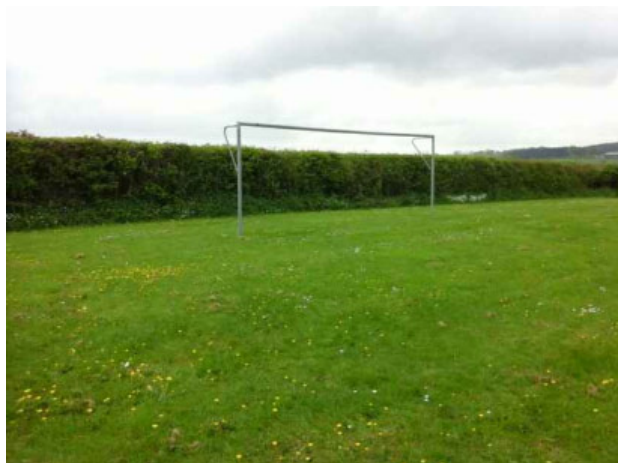
**Finding:** The paintwork on this item has been damaged or worn exposing the metal underneath which is rusting

**Action:** Treat any rusting components and repaint

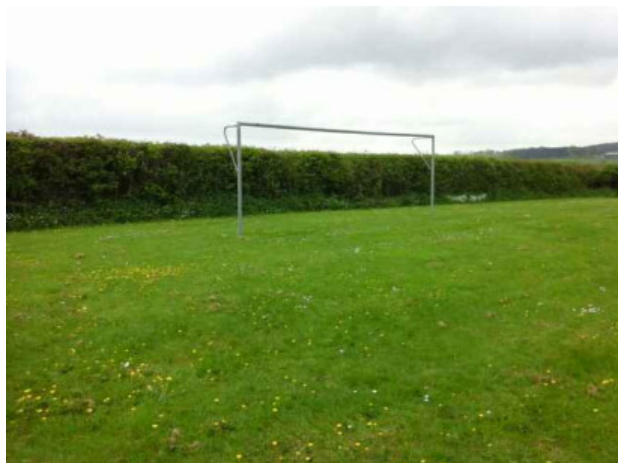
**Item:** Multi Use Games Area - Football Goal  
**Risk Level:** L - Low Risk  
**Manufacturer:** Unknown  
**Surface:** Grass

**Finding:** A number of fixing(s) have worked loose  
**Action:** Secure all loose fixings
