## Annual Inspection

TK Play

Frithelstock Parish Playing Fields

Annual Inspection - 13 May 2016 at 11:21 Inspector: Dr. Jody Chilton RPII Annual Inspector

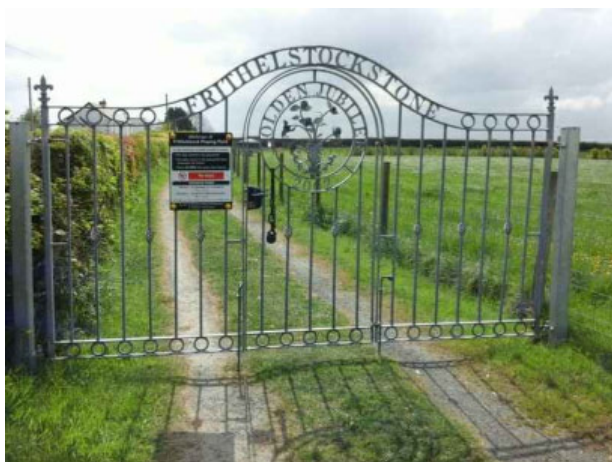
The gate was locked at the time of the inspection and could not be assessed - N/A

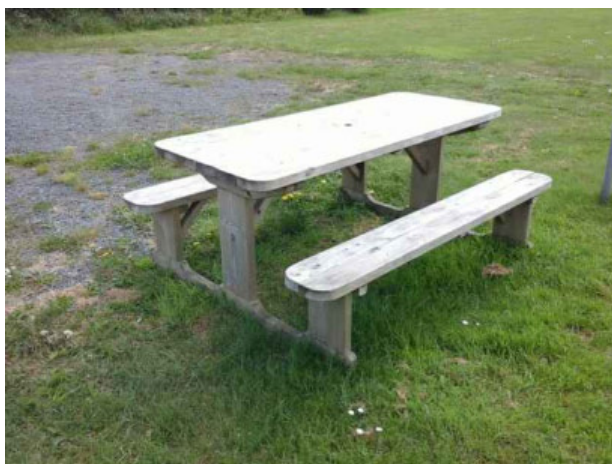
The bench is not securely fixed to the surface and there is some possibility of the item tipping or rolling over - Secure the bench to the ground

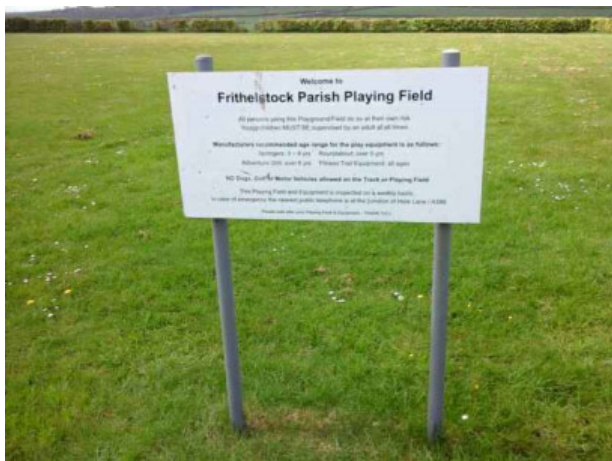
The sign has sharp projecting corners - Remove sharp corners/edges as required

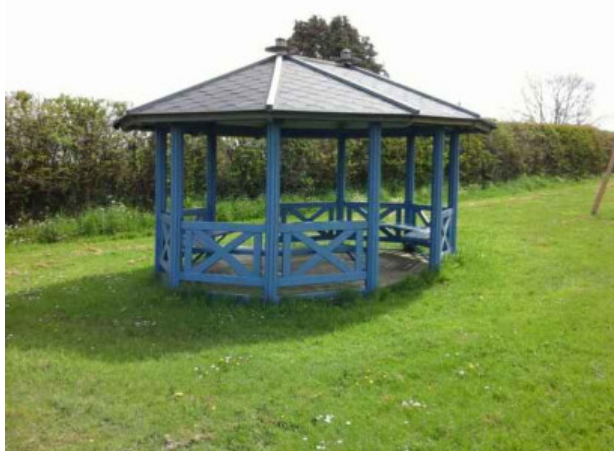
There is some damage to the floor creating a trip point - Repair as required to remove trip point

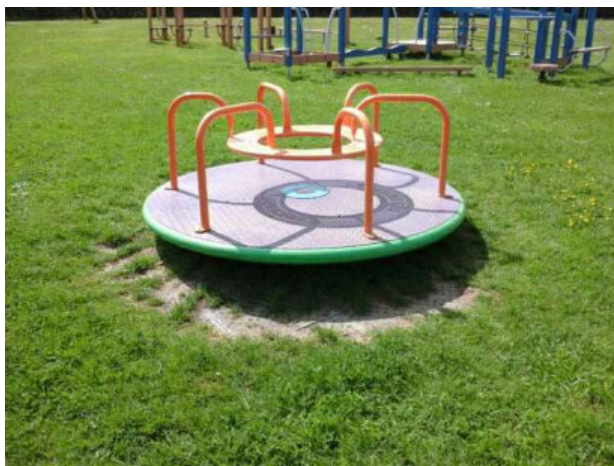
The grass mats are silted up and the soil is compacted; this may have an effect on the impact absorbing properties of the surface - Lift and relay mats or test impact absorbing properties to ensure the correct surface qualities are maintained for the equipment

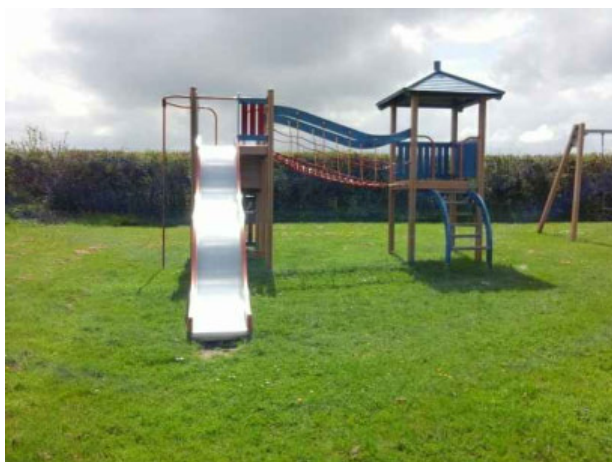
The item fails to meet the requirements of BS EN 1176:2008 Part 1 4.2.7.2 for head and neck entrapment in the curved access net - Monitor use

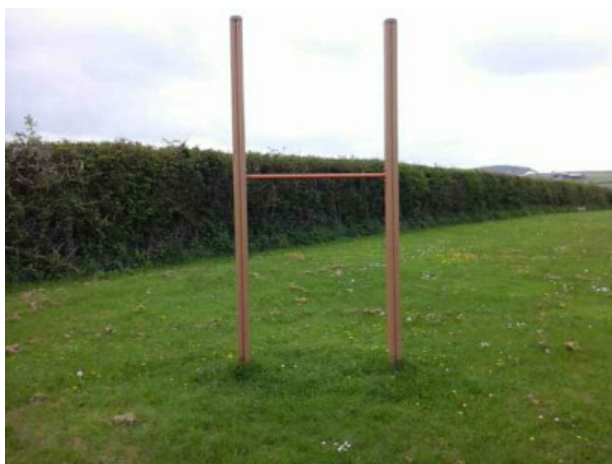
The item of equipment has a fall height exceeding 1.50 metres and grass has been provided as a safety surface - Provide a suitable impact attenuating surface

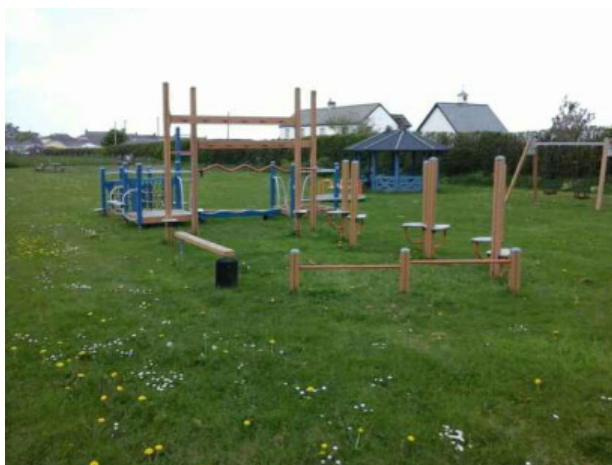
There are falls in excess of 600mm between adjacent components on the structure - Monitor use

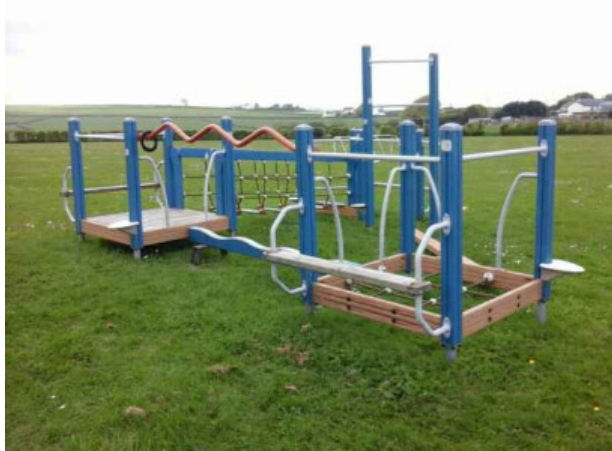
There are falls in excess of 600mm between adjacent components on the structure - Monitor use

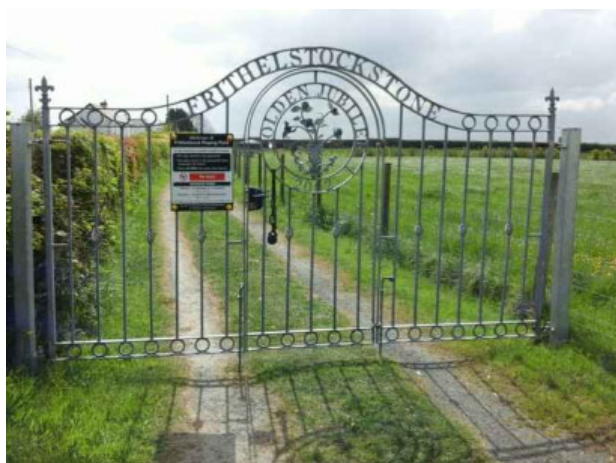
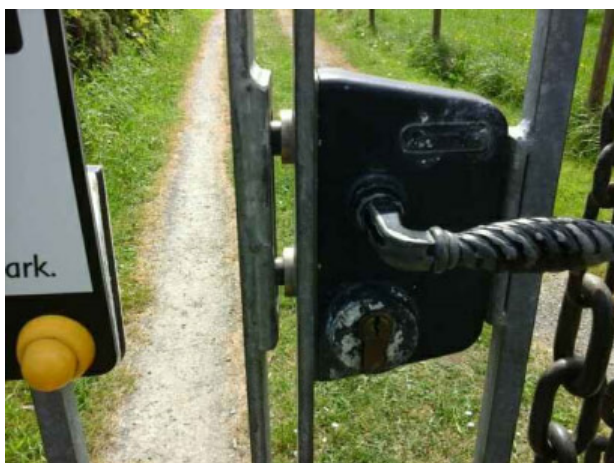
**Finding:** The gate was locked at the time of the inspection and could not be assessed

**Action:** N/A

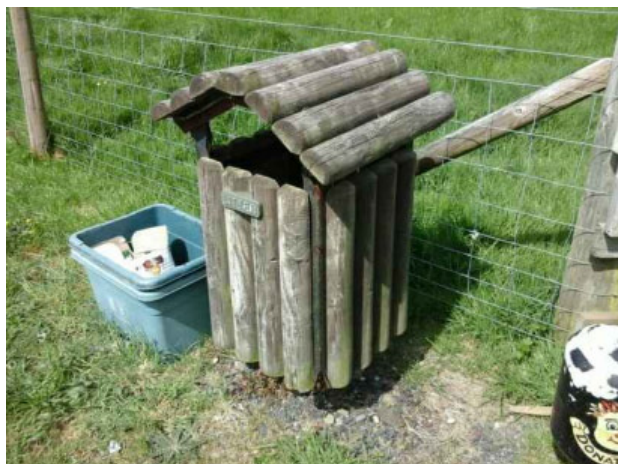
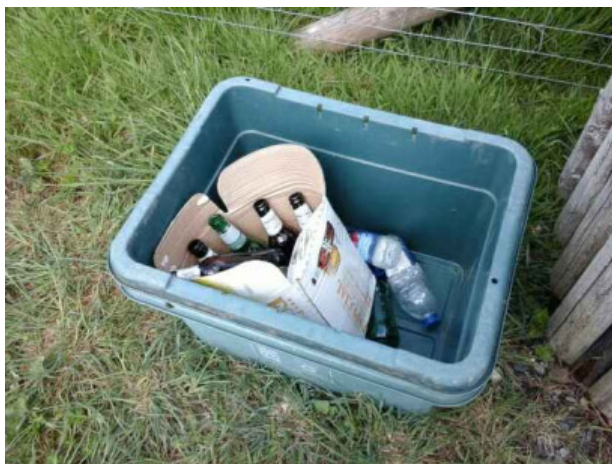
**Finding:** There is a box of bottles present

**Action:** Remove

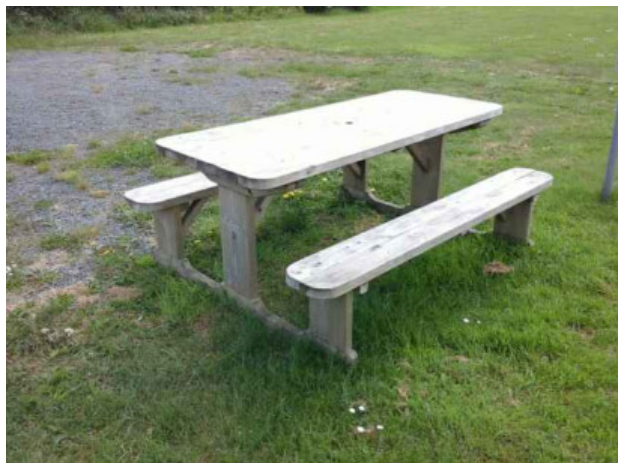
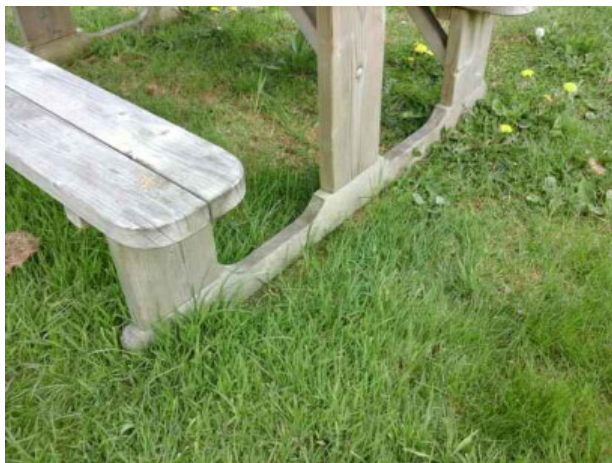
**Finding:** The bench is not securely fixed to the surface and there is some possibility of the item tipping or rolling over

**Action:** Secure the bench to the ground

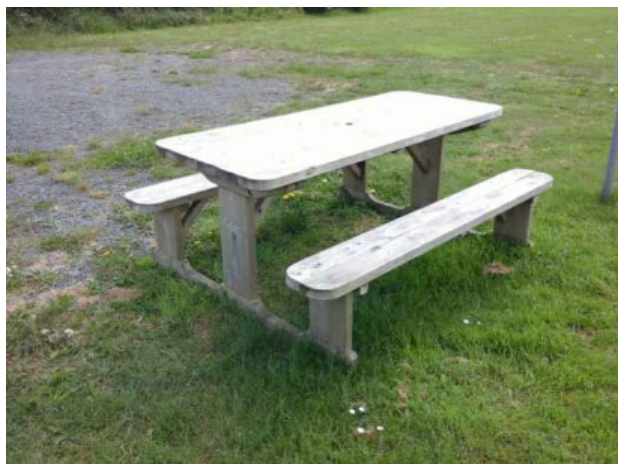
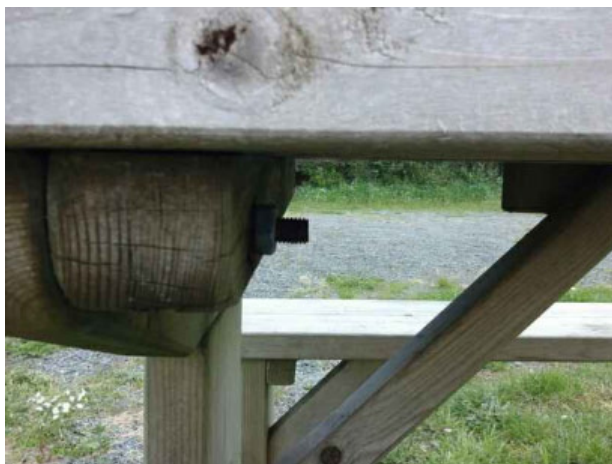
**Finding:** There are projecting bolt thread(s) present

**Action:** Remove excess thread length and deburr or provide cap

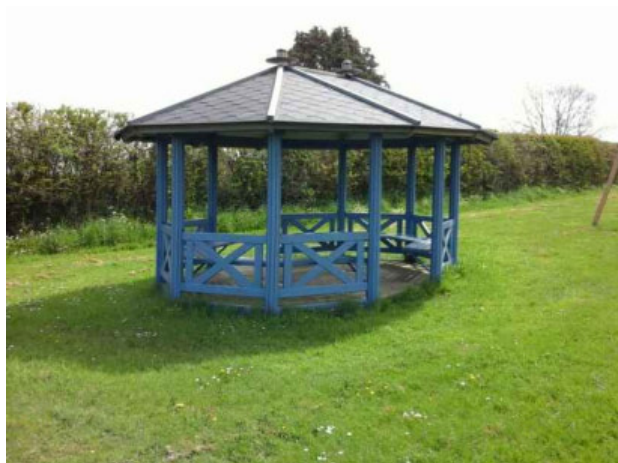
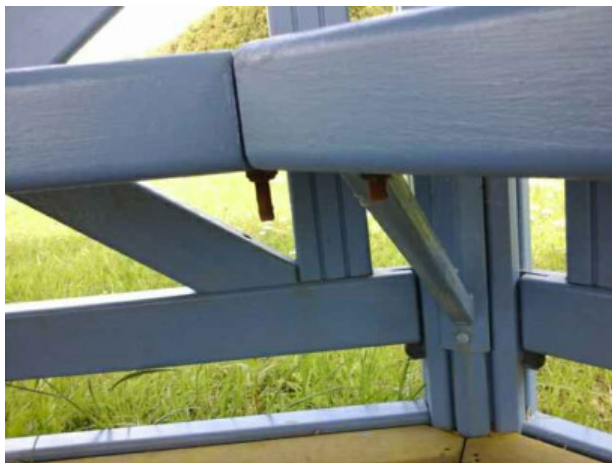
**Finding:** There are projecting bolt thread(s) present

**Action:** Remove excess thread length and deburr or provide cap

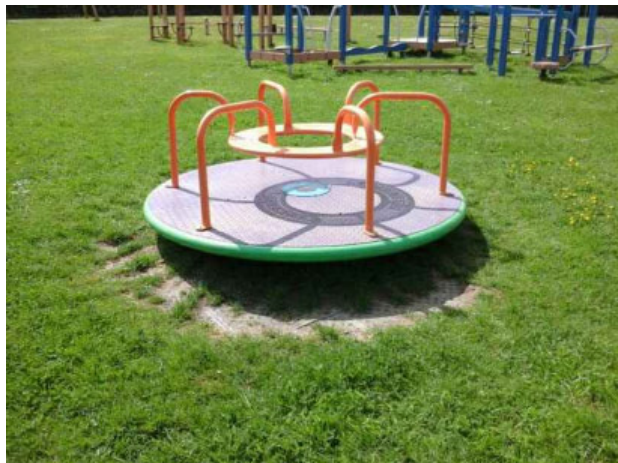
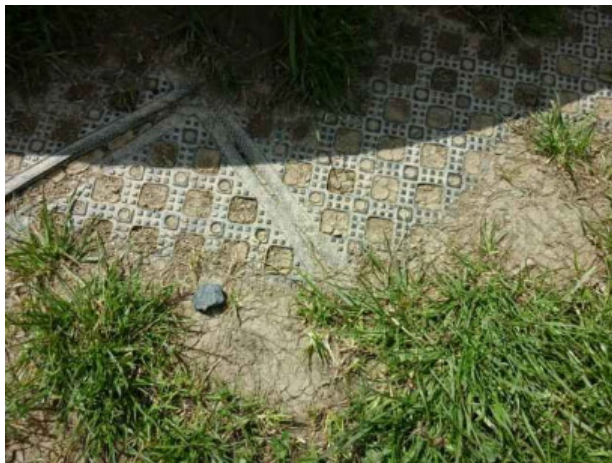
**Finding:** The grass mats are silted up and the soil is compacted; this may have an effect on the impact absorbing properties of the surface

**Action:** Lift and relay mats or test impact absorbing properties to ensure the correct surface qualities are maintained for the equipment

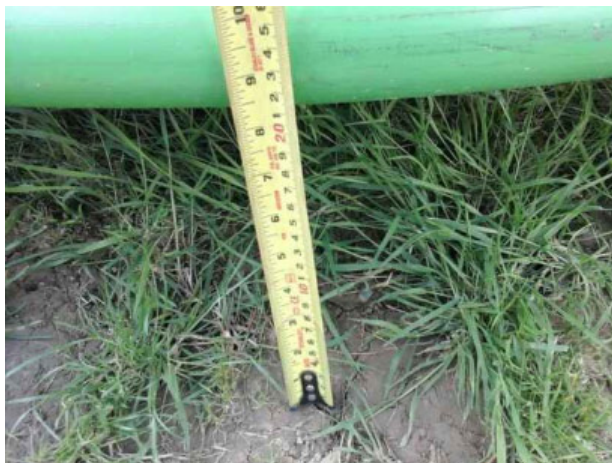
**Finding:** The distance between the underside of the roundabout platform and the playing surface is in excess of 110mm and contravenes the requirements of BS EN 1176 Part 5 which requires that the distance be maintained between 60mm-110mm - for the entire circumference of the roundabout

**Action:** Monitor use

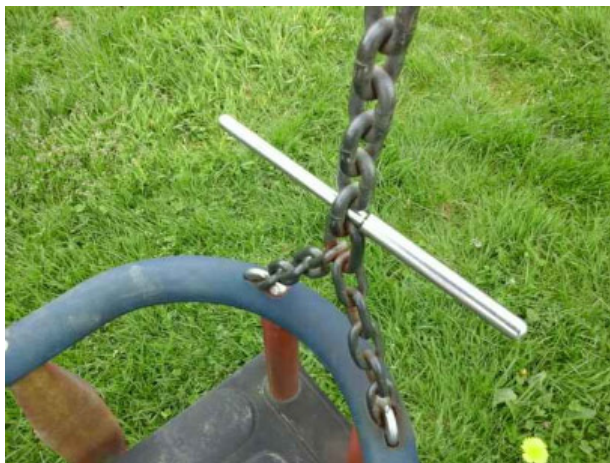
**Finding:** The chain openings are in excess of the 8.6mm as recommended by BS EN 1176

**Action:** Monitor use and replace with compliant chains during next maintenance cycle.

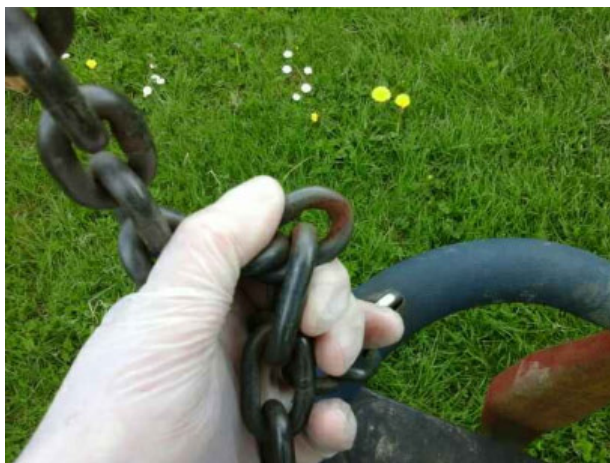
**Finding:** There is some chain wear

**Action:** Monitor for any further deterioration and replace when 40% worn

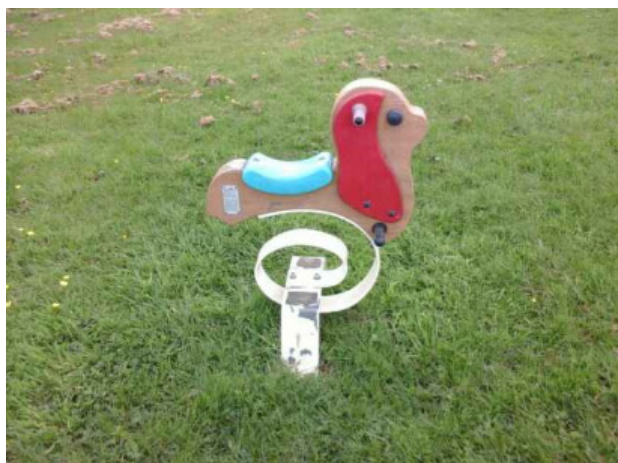
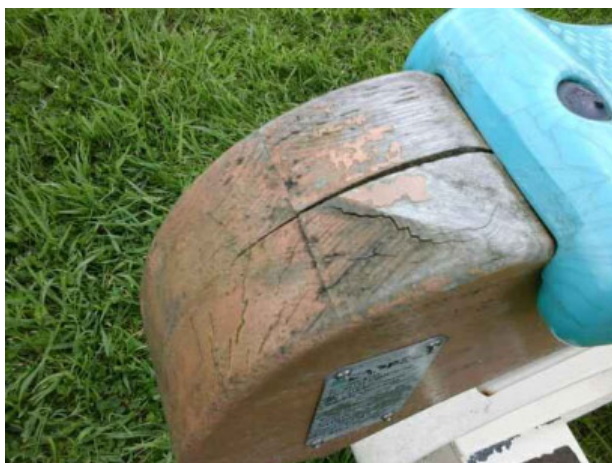
**Finding:** The plywood has delaminated in some places

**Action:** Remove all rough or splintered edges.

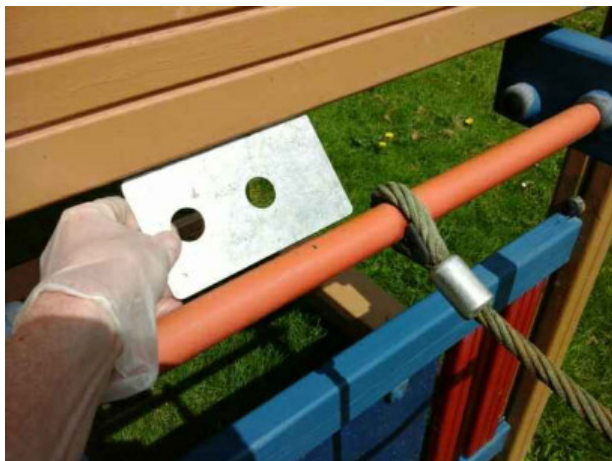
**Finding:** The item fails to meet the requirements of BS EN 1176:2008 Part 1 4.2.7.2 for head and neck entrapment in the curved access net

**Action:** Monitor use

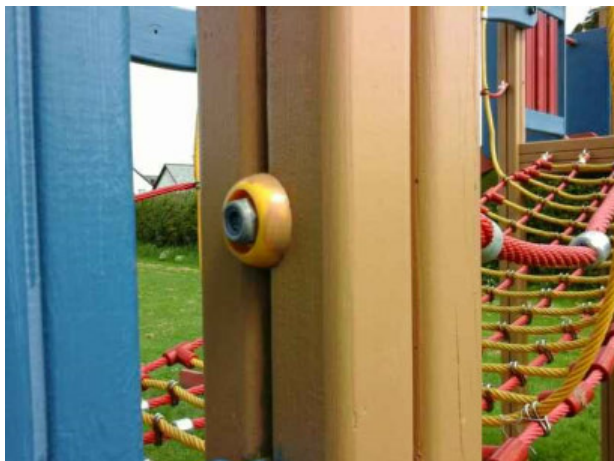
**Finding:** There is/are bolt cap covers missing or damaged on the item

**Action:** Replace missing or damaged bolt cap covers

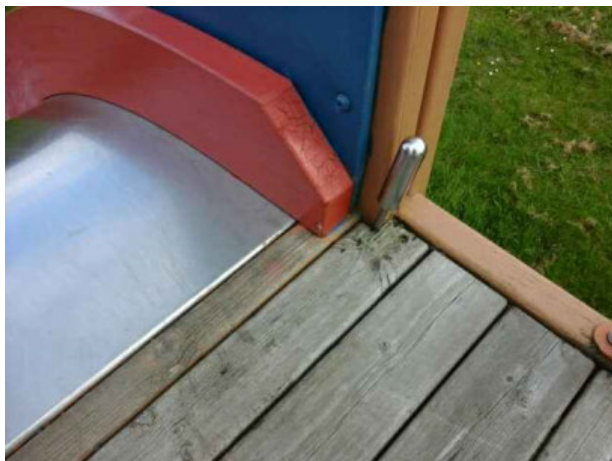
**Finding:** There is/are finger entrapment/s in the platform at the top of the slide and the item fails to meet the requirements of BS EN 1176:2008 Part 1 4.2.7.6 Entrapment of fingers

**Action:** Monitor use

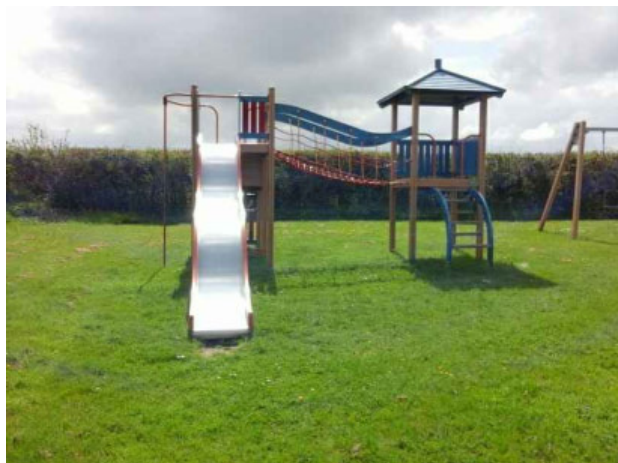
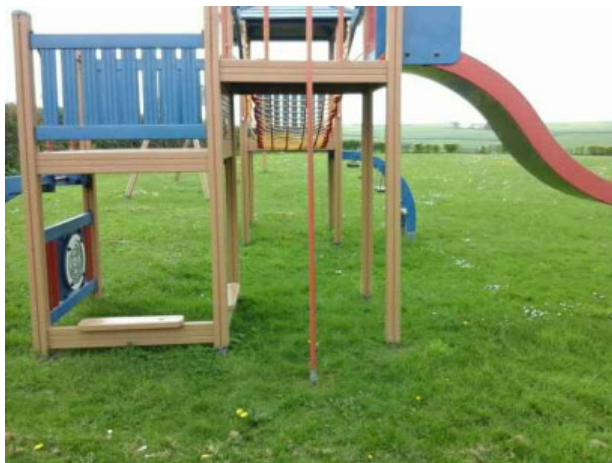
**Finding:** The item of equipment has a fall height exceeding 1.50 metres and grassmats are buried potentially affecting their impact attenuating properties.

**Action:** Lift and relay the mats or provide a new suitable impact attenuating surface

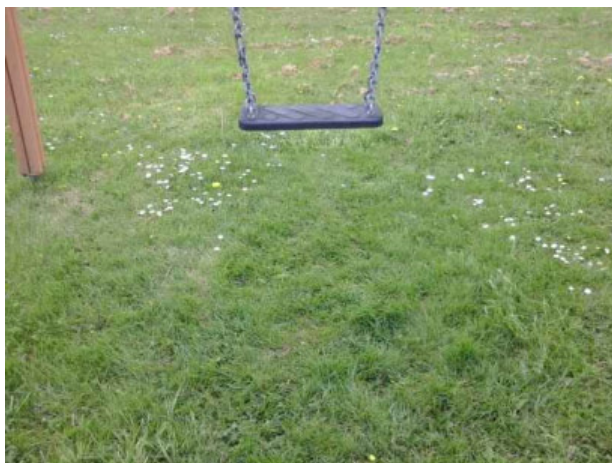
**Finding:** The seats are over 650mm high and may be difficult for some users to access

**Action:** Consider lengthening the chains to lower the seats

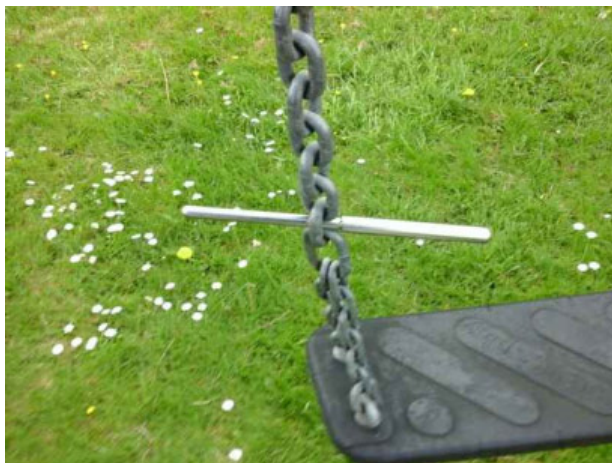
**Finding:** The chain openings are in excess of the 8.6mm as recommended by BS EN 1176

**Action:** Monitor use and replace with compliant chains during next maintenance cycle.

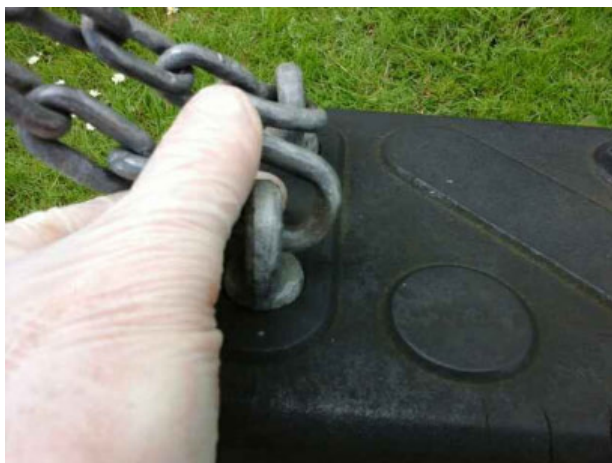
**Finding:** There is some chain wear

**Action:** Monitor for any further deterioration and replace when 40% worn

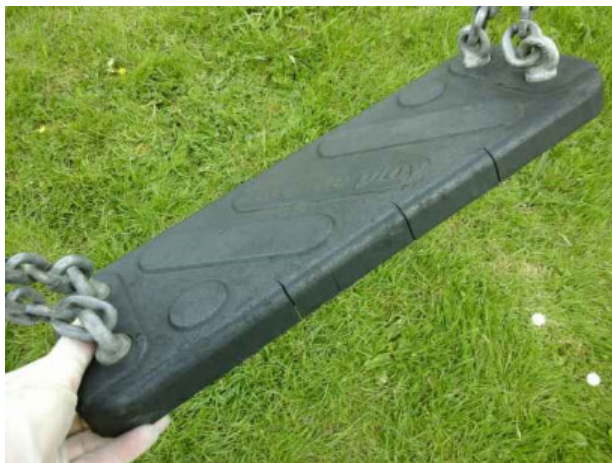
**Finding:** The seat has minor damage or wear

**Action:** Monitor for any further deterioration and replace as required

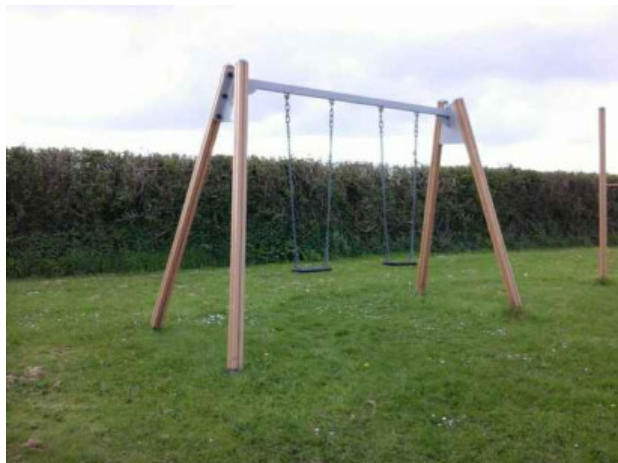
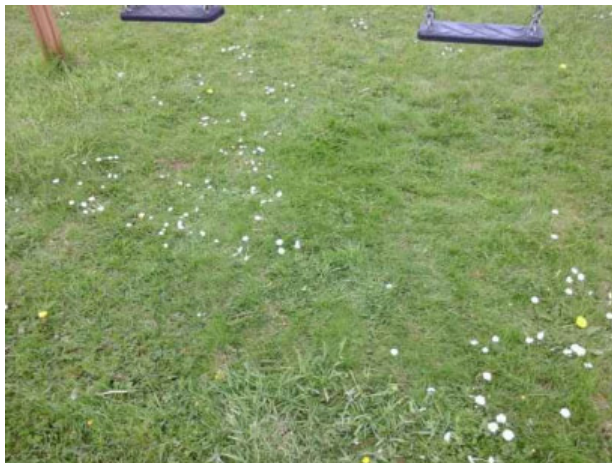
**Finding:** The item of equipment has a fall height exceeding 1.50 metres and the grassmats have been buried potentially affecting their impact attenuating properties.

**Action:** Lift and relay the mats or provide a new suitable impact attenuating surface

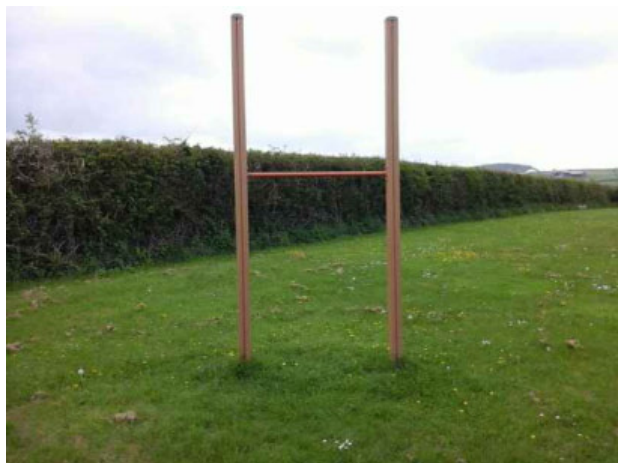
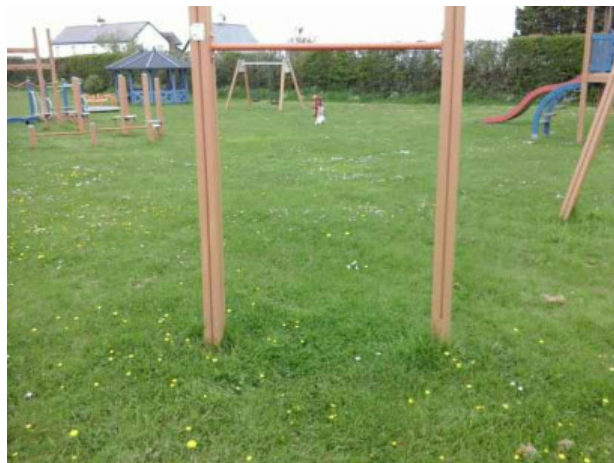
**Item:** Activity Equipment - Somersault Bars  
**Manufacturer:** Lappset UK Ltd

**Risk Level:** L - Low Risk  
**Surface:** Grass

**Finding:** The item of equipment has a fall height exceeding 1.50 metres and grass has been provided as a safety surface

**Action:** Provide a suitable impact attenuating surface

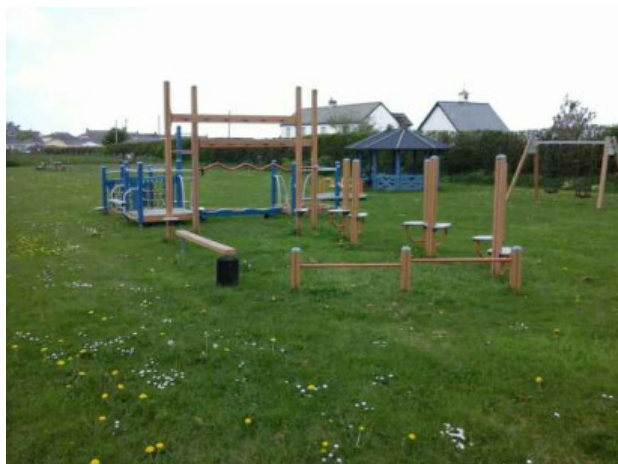
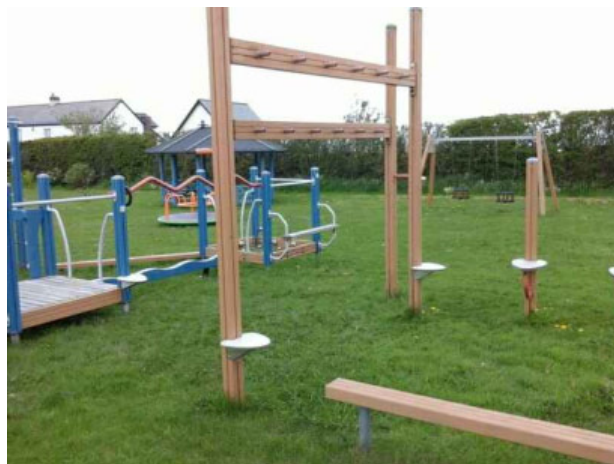
**Item:** Activity Equipment - Adventure Trail  
**Manufacturer:** Lappset UK Ltd

**Risk Level:** L - Low Risk  
**Surface:** Grass

**Finding:** There are falls in excess of 600mm between adjacent components on the structure

**Action:** Monitor use

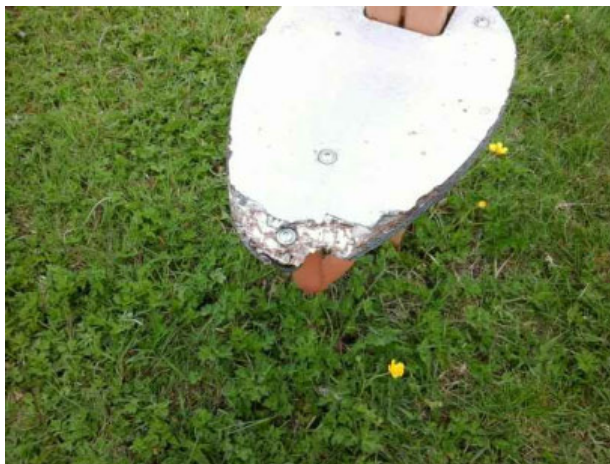
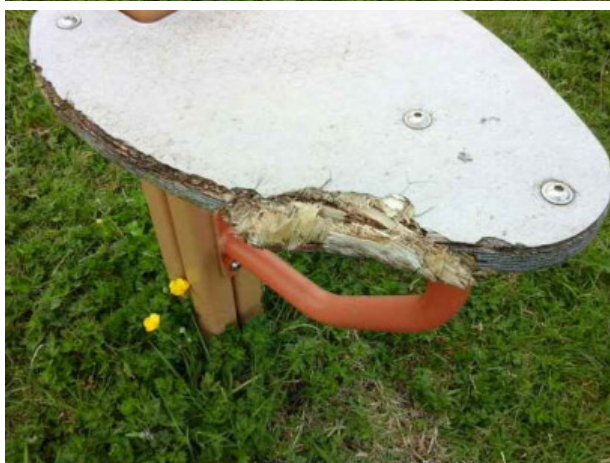
**Item:** Activity Equipment - Adventure Trail  
**Manufacturer:** Lappset UK Ltd

**Risk Level:** M - Moderate Risk  
**Surface:** Grass

**Finding:** There are areas or parts of the timber stilt platforms on the structure that have rotted around fixing points

**Action:** Replace all affected timbers

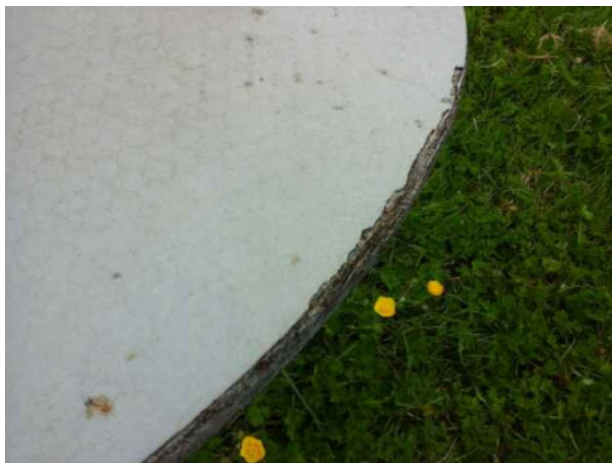
**Item:** Activity Equipment - Adventure Trail  
**Manufacturer:** Lappset UK Ltd

**Risk Level:** L - Low Risk  
**Surface:** Grass

**Finding:** Parts of the timber are rough or splintered

**Action:** Remove all rough or sharp edges

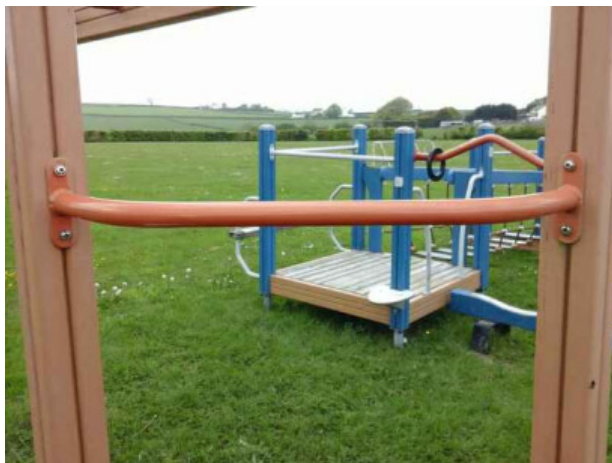
**Item:** Activity Equipment - Adventure Trail  
**Manufacturer:** Lappset UK Ltd

**Risk Level:** L - Low Risk  
**Surface:** Grass

**Finding:** A number of fixing(s) have worked loose

**Action:** Secure all loose fixings

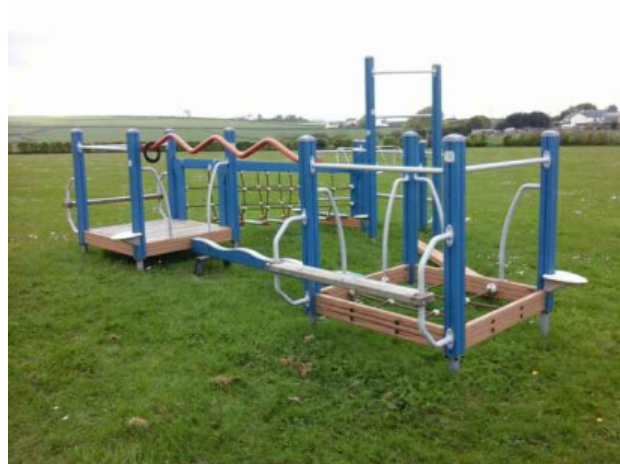
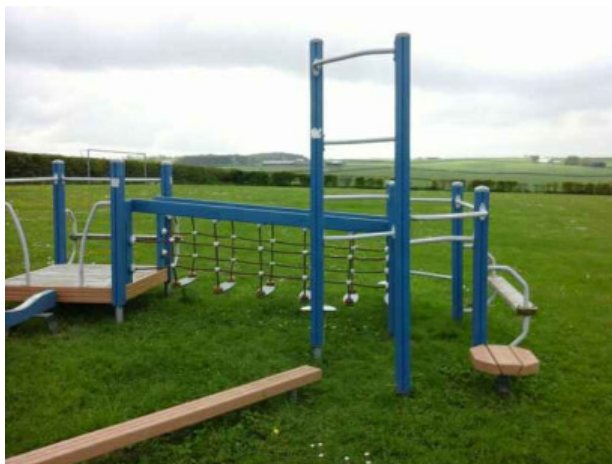
**Item:** Activity Equipment - Activity Trail  
**Manufacturer:** Lappset UK Ltd

**Risk Level:** L - Low Risk  
**Surface:** Grass

**Finding:** There are falls in excess of 600mm between adjacent components on the structure

**Action:** Monitor use

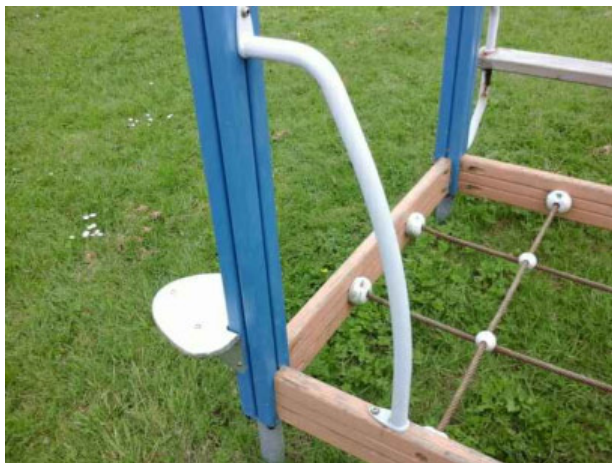
**Item:** Activity Equipment - Activity Trail  
**Manufacturer:** Lappset UK Ltd

**Risk Level:** L - Low Risk  
**Surface:** Grass

**Finding:** A number of handle fixing(s) have worked loose

**Action:** Secure all loose fixings

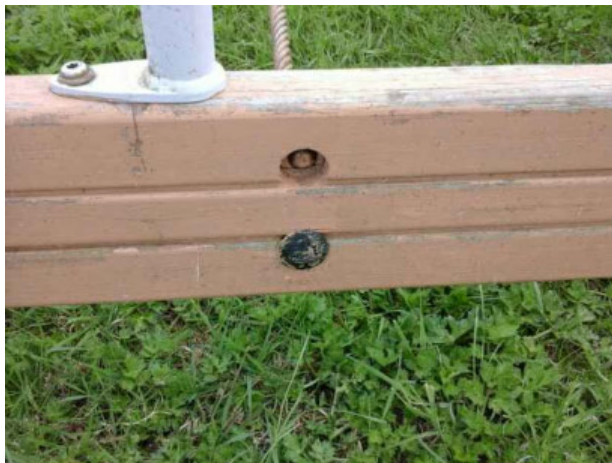
**Item:** Activity Equipment - Activity Trail  
**Manufacturer:** Lappset UK Ltd

**Risk Level:** L - Low Risk  
**Surface:** Grass

**Finding:** There is/are several inserts missing

**Action:** Replace missing inserts

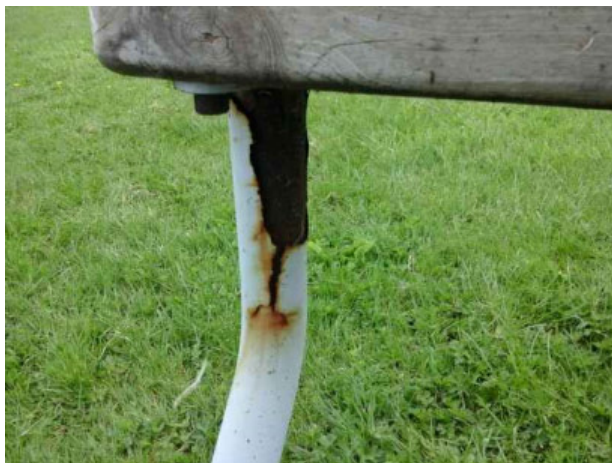
**Item:** Activity Equipment - Activity Trail  
**Manufacturer:** Lappset UK Ltd

**Risk Level:** L - Low Risk  
**Surface:** Grass

**Finding:** The paintwork on this item has been damaged or worn exposing the metal underneath which is rusting

**Action:** Treat any rusting components and repaint

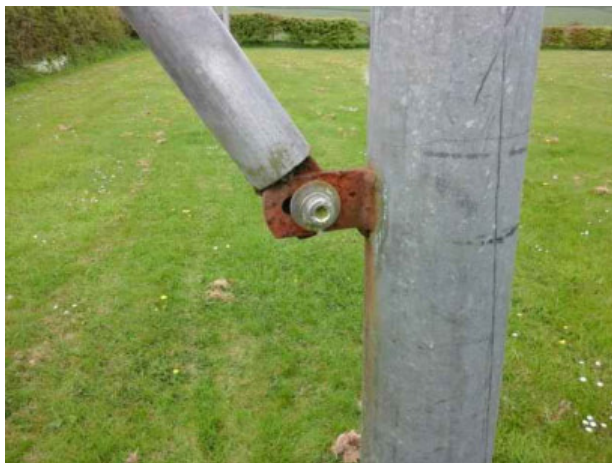
**Item:** Multi Use Games Area - Football Goal  
**Manufacturer:** Unknown

**Risk Level:** L - Low Risk  
**Surface:** Grass

**Finding:** The paintwork on this item has been damaged or worn exposing the metal underneath which is rusting

**Action:** Treat any rusting components and repaint

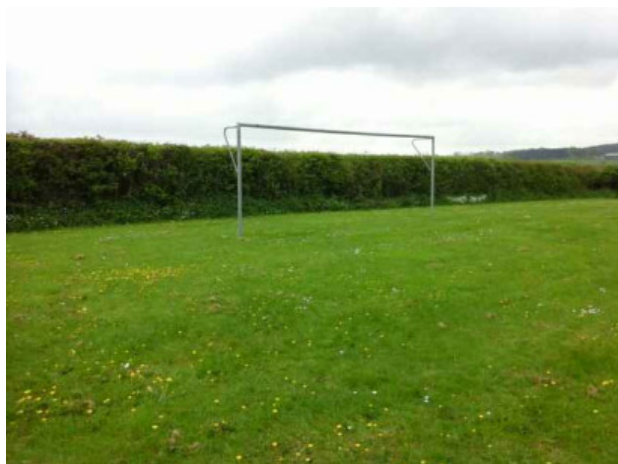
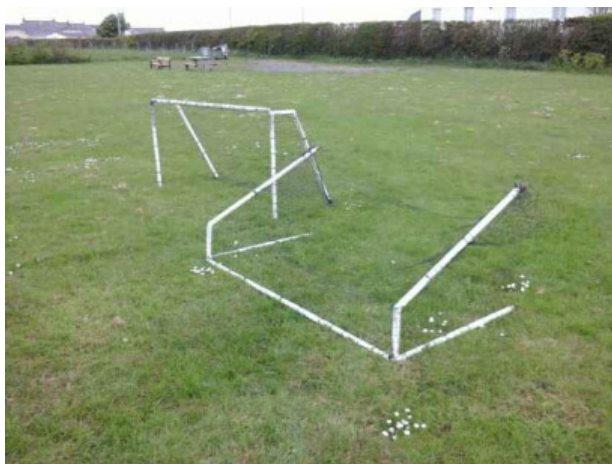
**Item:** Multi Use Games Area - Football Goal  
**Manufacturer:** Unknown

**Risk Level:** L - Low Risk  
**Surface:** Grass

**Finding:** The 5 a side goals and nets are not secured to the ground and there is some possibility of the item tipping over

**Action:** Secure the goals

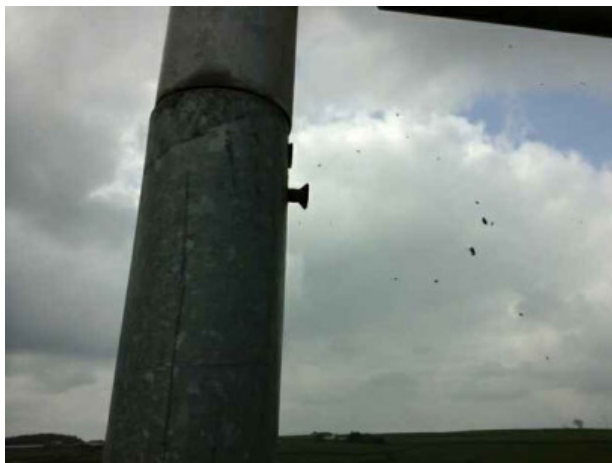
## 6 - Low Risk (Finding 4)

**Item:** Multi Use Games Area - Football Goal  
**Risk Level:** L - Low Risk  
**Manufacturer:** Unknown  
**Surface:** Grass

**Finding:** A number of fixing(s) have worked loose  
**Action:** Secure all loose fixings
